November 18, 2016

RE: Your File: 3960.00, Fairway Colony Wastewater Treatment Lagoon, Secondary Cell Liner

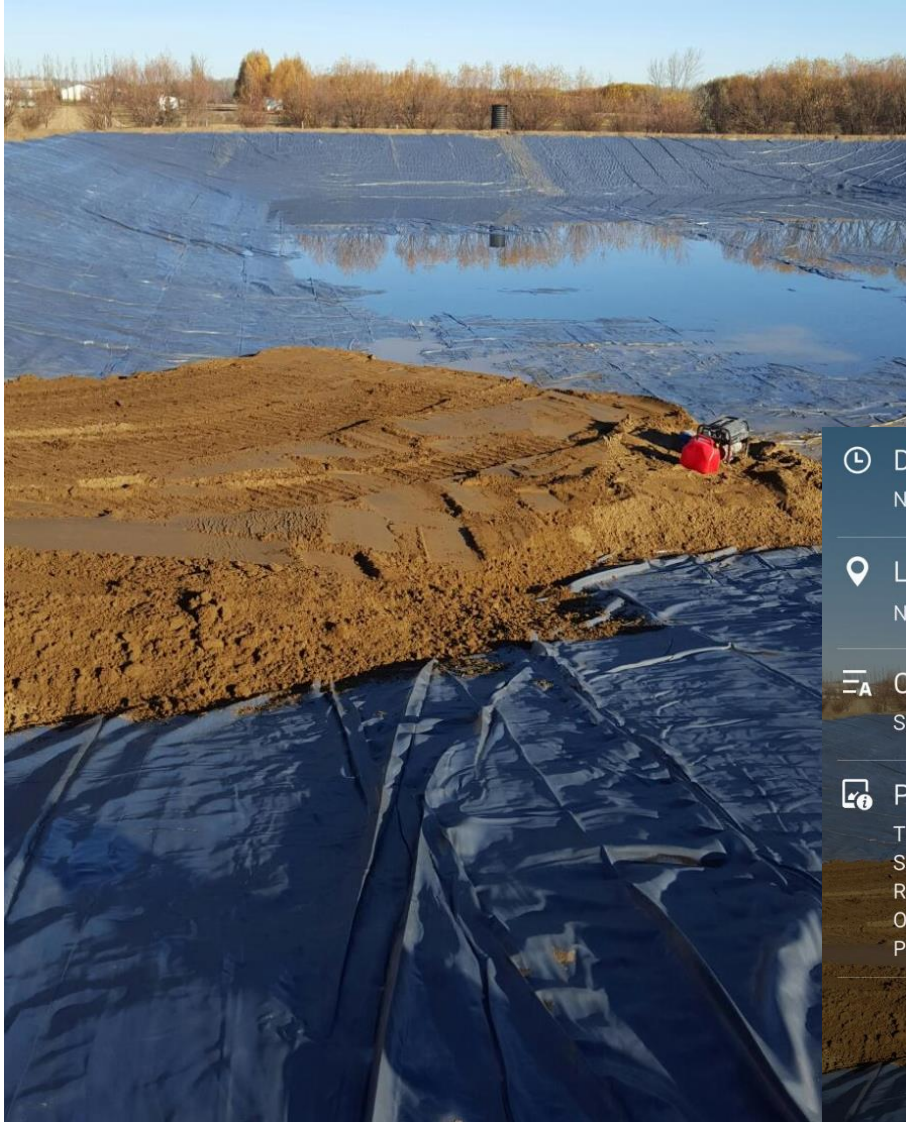
November 5, 2016 at 11:02am.  
Ambient daytime temperature 19C, dry and sunny.  
Photo taken from SW corner looking north.

Installation of ballast material to build a ramp in SW corner of cell to allow equipment and pedestrian entry into cell. Two inch submersible pumps were used to remove water accumulated in the cell from a rain event on October 31. Water was fluid and not frozen when we entered the cell.

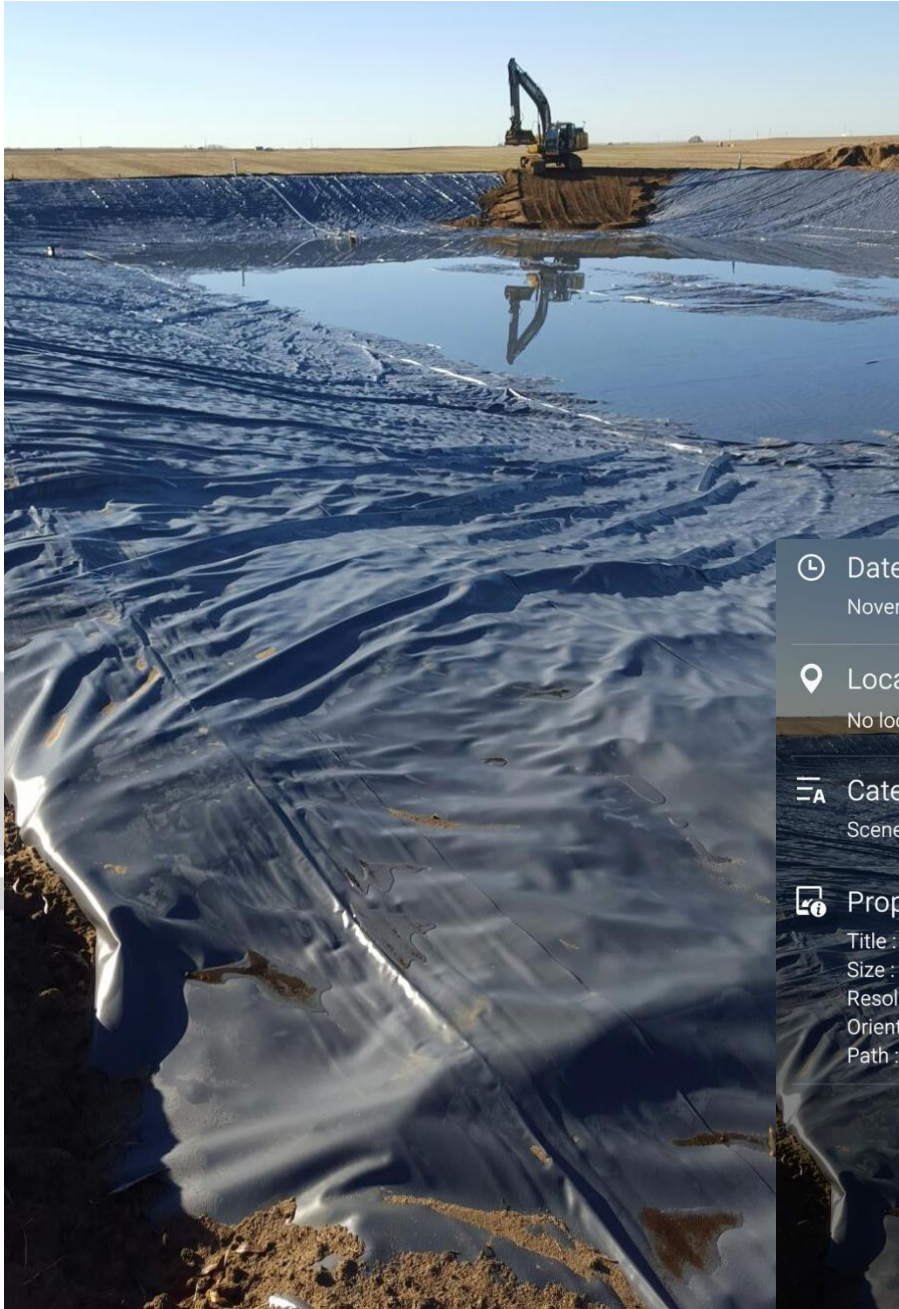
November 5, 2016 at  
11:05am.  
Ambient daytime  
temperature 19C, dry and  
sunny.  
Photo taken from NE  
corner looking south.

Two inch submersible pumps were used to remove water accumulated in the cell from a rain event on October 31. Water was fluid and not frozen when we entered the cell.

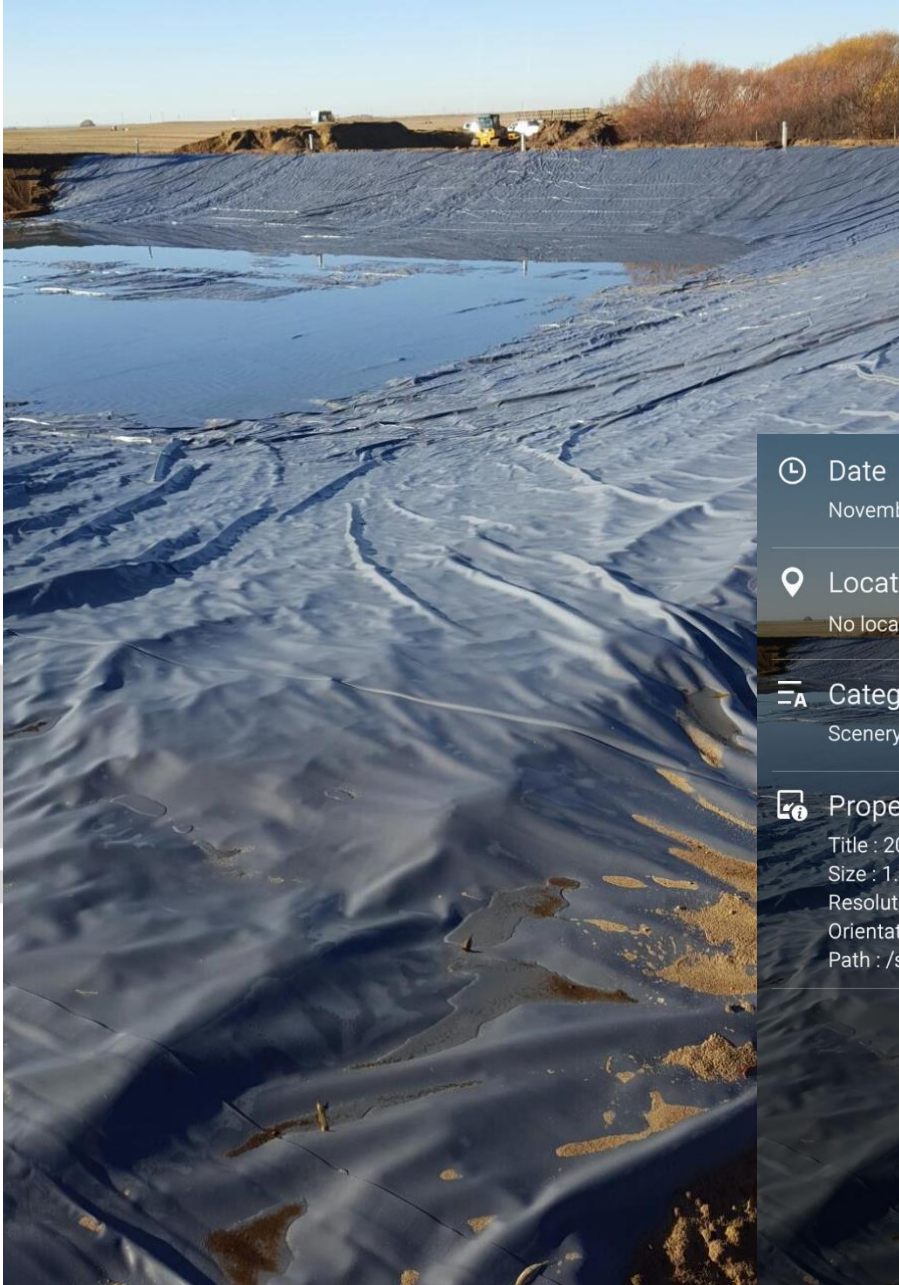
November 5, 2016 at  
11:05am  
Ambient daytime  
temperature 19C, dry and  
sunny.  
Photo taken from NE  
corner looking SW.

Two inch submersible pumps were used to remove water accumulated in the cell from a rain event on October 31. Water was fluid and not frozen when we entered the cell.

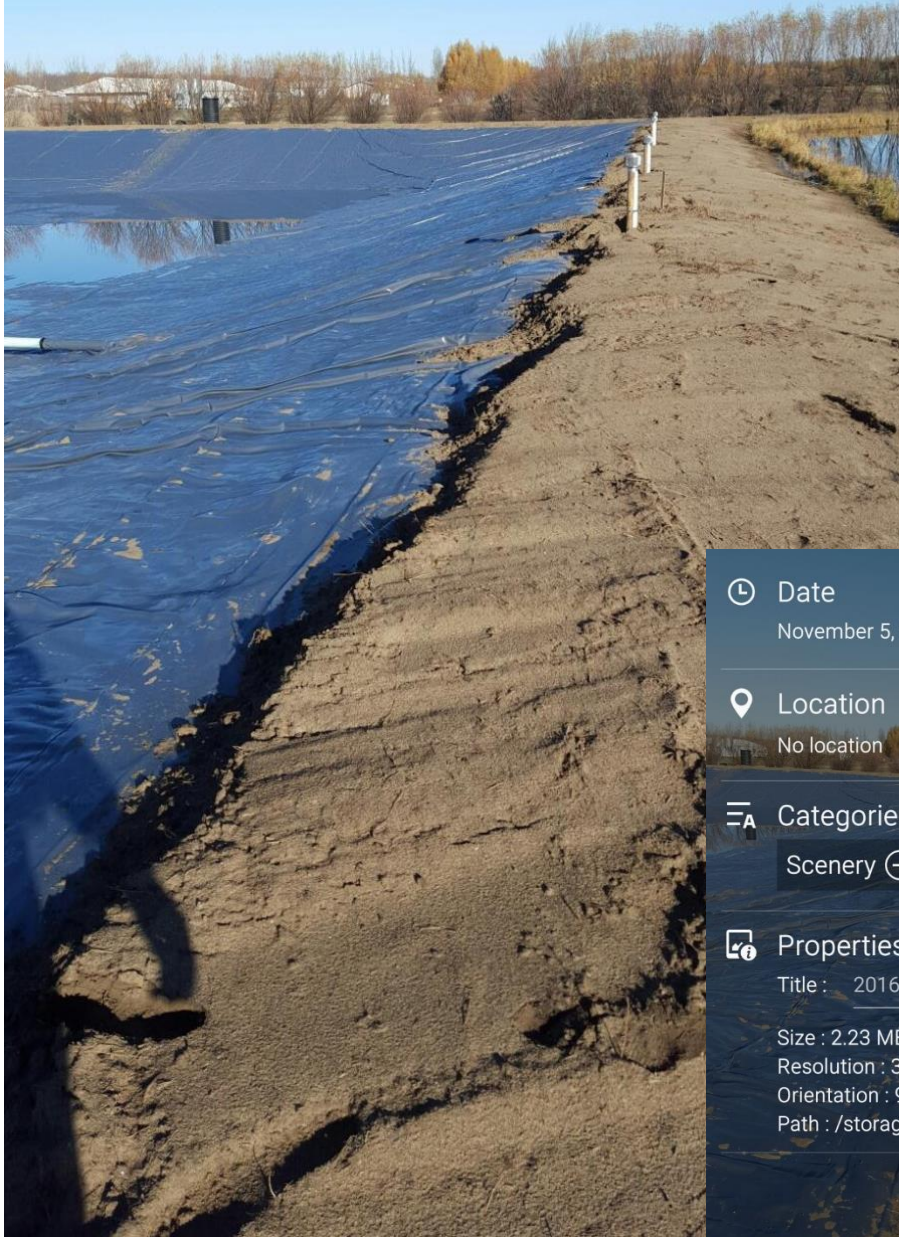
November 5, 2016 at 11:04am  
Ambient daytime temperature 19C, dry and sunny.  
Photo taken from SE corner looking along east berm anchor trench.  
Gas vents along east berm are visible.  
Interconnecting pipe is visible.

Two inch submersible pumps were used to remove water accumulated in the cell during from a rain event on October 31. Water was fluid and not frozen when we entered the cell.

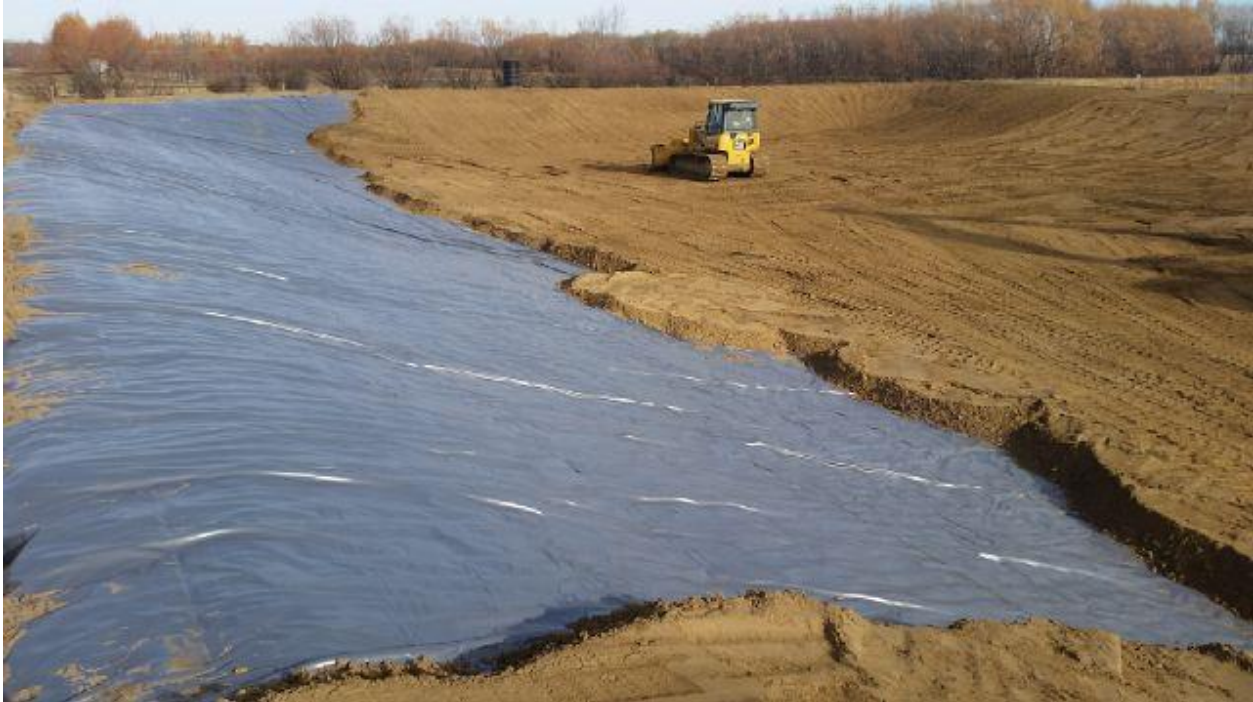
November 8, 2016 at 11:17am.  
Ambient daytime temperature 14C, dry and sunny.  
Photo is taken from SW corner looking north.  
Installation of ballast material is completed from centre  
of cell to east berm.

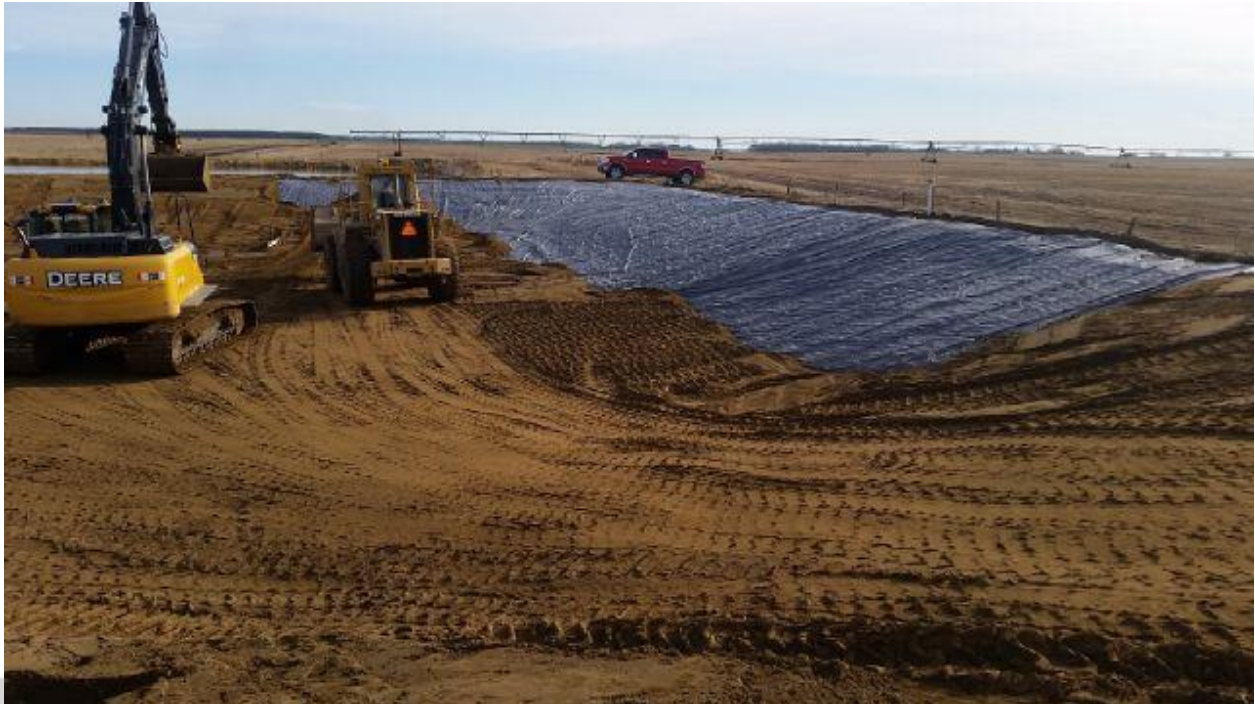
November 8, 2016 at 11:17am.  
Ambient daytime temperature 14C, dry and sunny.  
Photo is taken from SW corner looking east.  
Installation of ballast material is completed except for SE corner of cell.

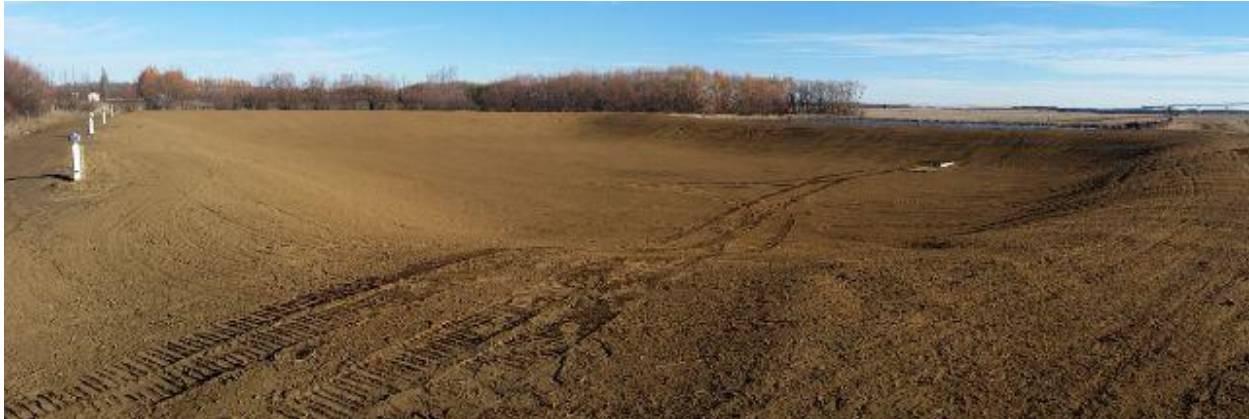
November 9, 2016 at 10:27am.  
Ambient daytime temperature 20C, dry and sunny.  
Photo is taken from SW corner in panoramic view to show complete cell.  
Installation of ballast material is completed.  
Gas vents along west berm are visible.  
Interconnecting pipe through east wall of cell is visible.

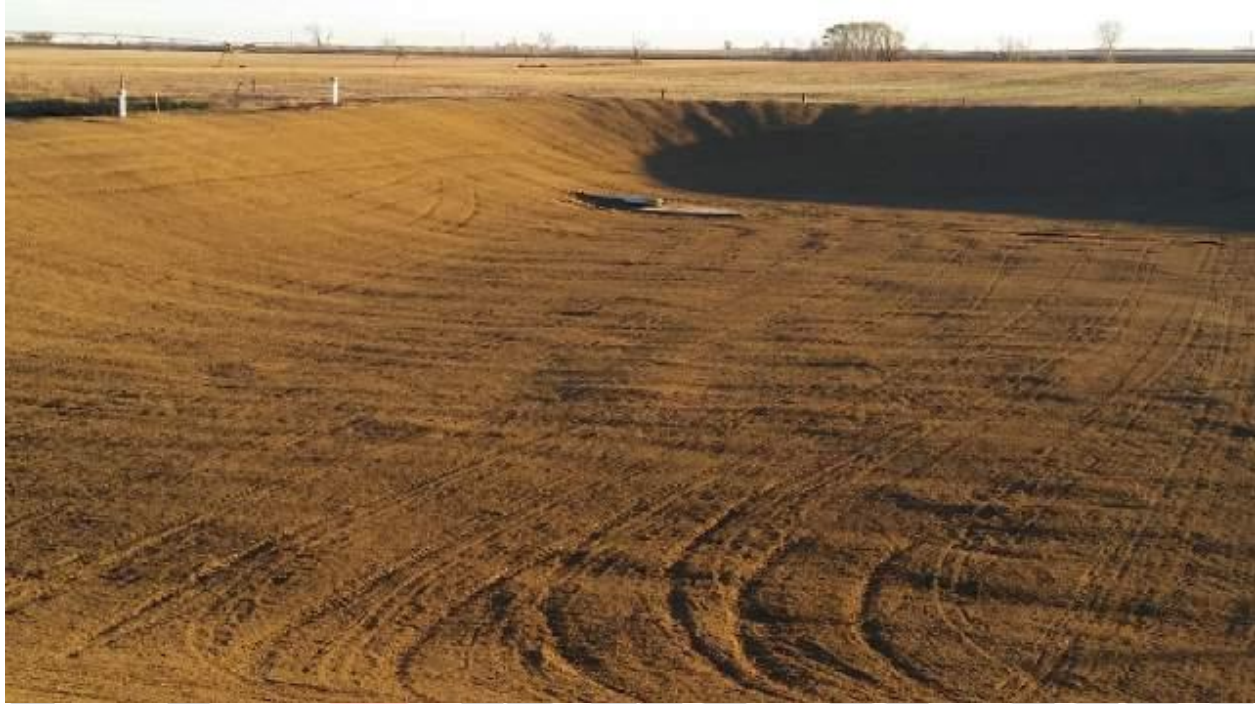
- (1) *The interconnecting pipe between cells is to be trimmed back such that the extension beyond the interior surface is minimized once the ballast material has been installed. Once ballast material was installed, the placement of the pipe was suitable and it was not necessary to trim back the pipe.*

November 9, 2016 at 4:15pm.  
Ambient daytime temperature 20C, dry and sunny.  
Photo is taken from north berm, looking to SE corner.  
Installation of ballast material is completed.  
Interconnecting pipe is visible.

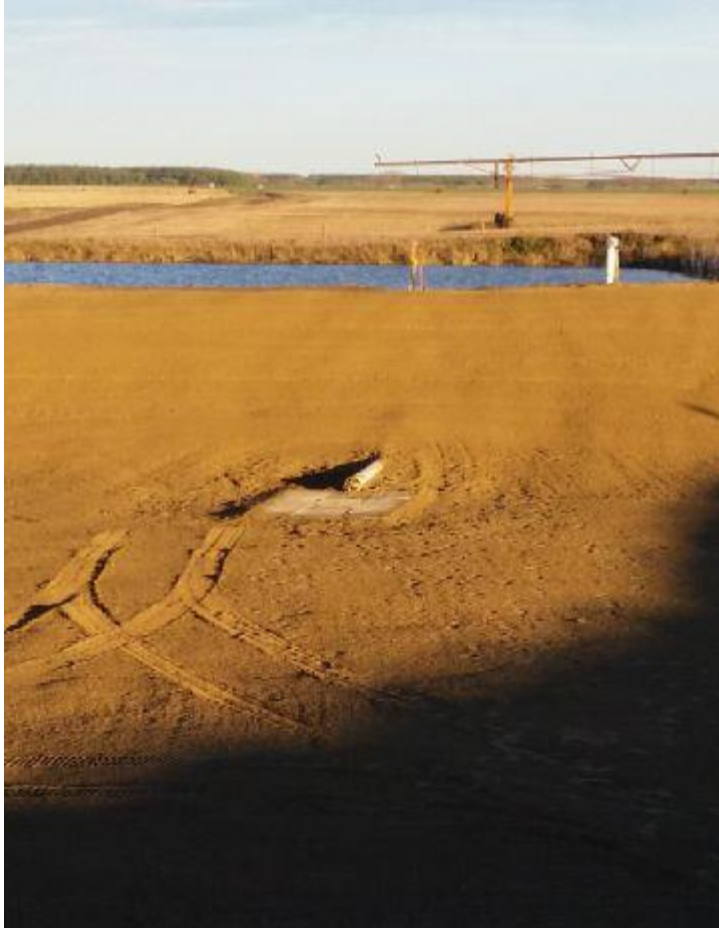
November 9, 2016 at 4:14pm.  
Ambient daytime temperature 20C, dry and sunny.  
Photo is taken from west berm looking east.  
Installation of ballast material is completed.  
Interconnecting pipe is visible.

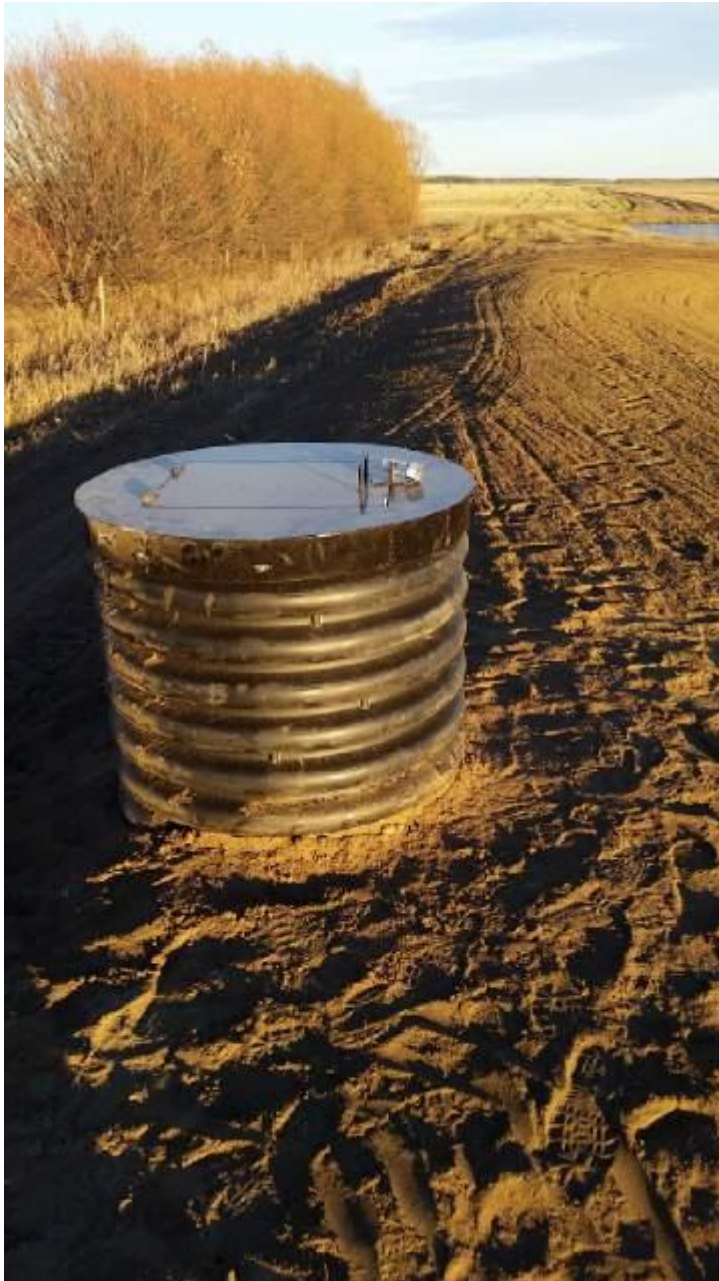
- (4) *Installation of the dewatering pump and fastening of the sump cover is to be completed prior to commissioning.* The Owner Fairway Colony is responsible for installation of the dewatering pump. EFM trimmed the sump height to 1.0m above top of berm, the cover was installed by bolting, and padlocked in place before EFM left the site on November 9, 2016.

November 9, 2016 at 4:15pm.  
Ambient daytime temperature 20C, dry and sunny.  
Photo taken on north berm looking east.  
Sump is trimmed to 1.0m above top of berm.  
The cover is bolted in place, and was padlocked when EFM left site.  
The Owner Fairway Colony is responsible for installation of the dewatering pump.
