**North End Water Pollution Control Centre (NEWPCC)
Flooded Pump Drywell Incident, September 17, 2002 -
Interim Report from the City of Winnipeg**

**Re: North End Water Pollution Control Centre (NEWPCC)
Flooded Pump Drywell Incident, September 16, 2002 - Interim Report
Our File No. 020-17-06-01-00**

This is the interim report to Manitoba Conservation. A final report will be submitted at such time as the cause for the incident has been established. This will require removal of the suspect valve which is the likely cause of the incident. Removal, for assurances of personnel and equipment safety, can only take place when no chance of wet weather flow exists. Removal of the valve is scheduled for later this month. You will be advised when a firm date is established. The failed valve has been double locked to prevent tampering, and will not be disturbed without witness by regulatory authorities. The City has retained a Consultant Engineering firm to isolate/remove the valve, and to design improvements for risk mitigation against this incident. Note that this report corrects and updates information in the daily email reports sent previously.

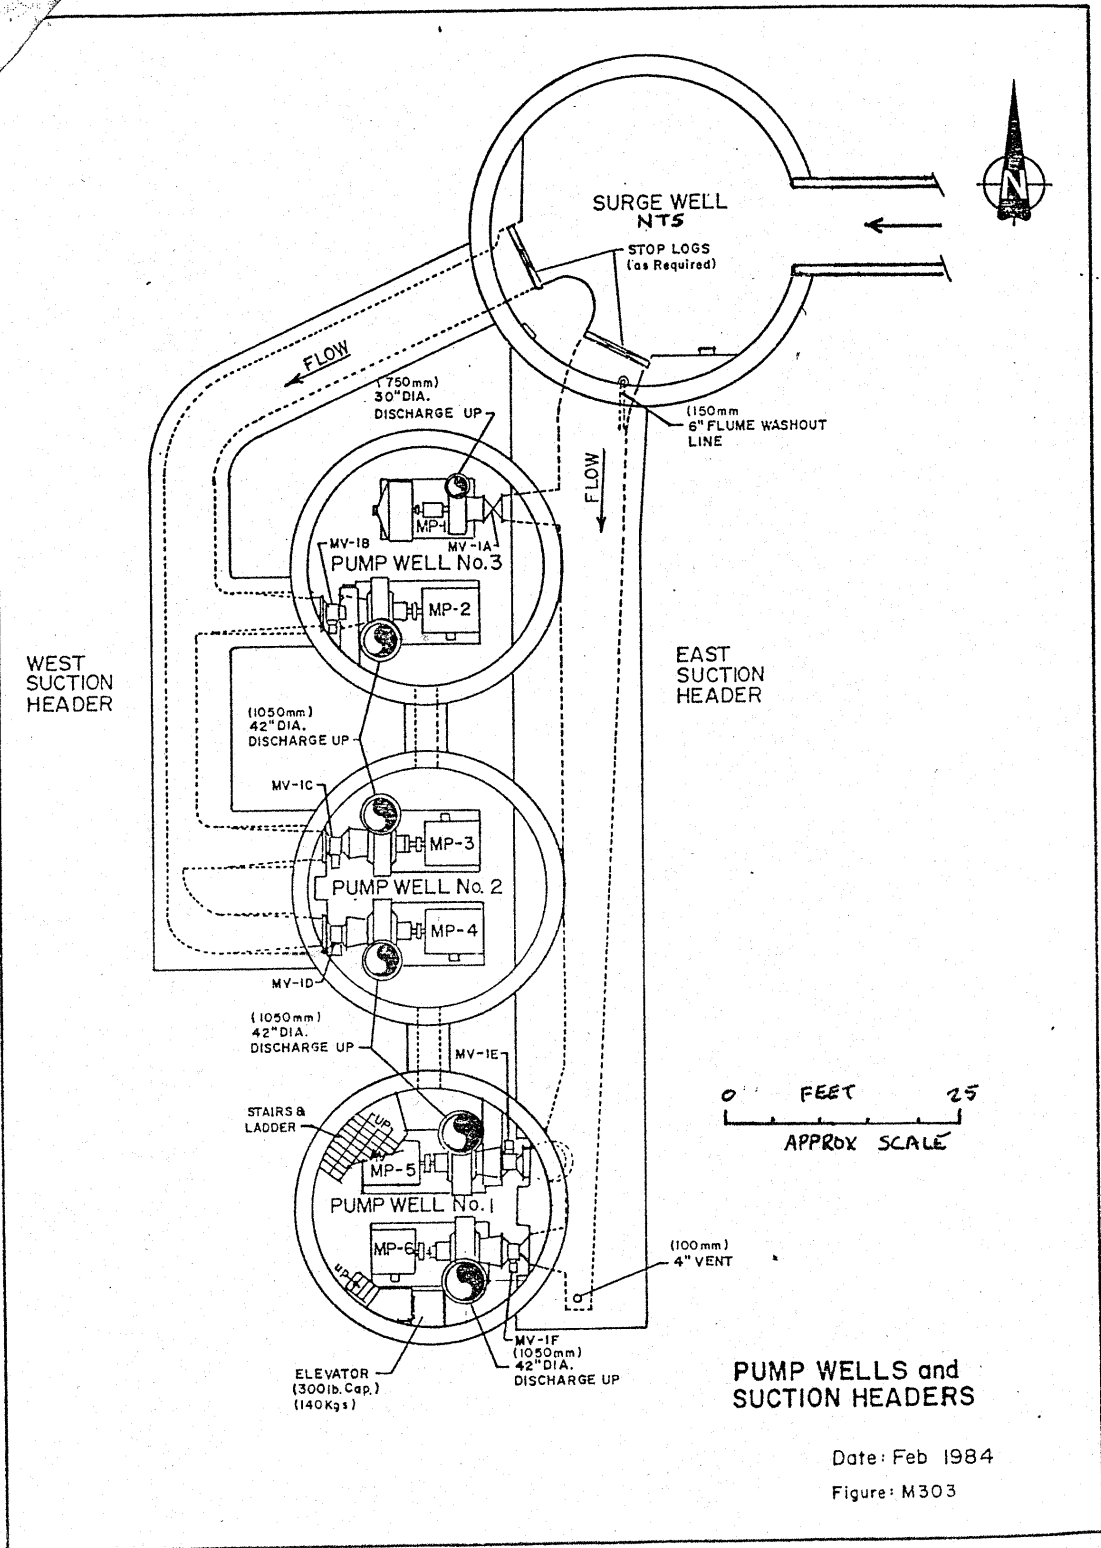
At approximately 1:15 p.m., Monday, September 16, 2002, a Wastewater Operator, with the assistance of a licensed Inter-Provincial Industrial Mechanic, was in Pump Drywell #1 (57 feet deep), in the process of removing an inspection plate on Main Pump MP5, one of the plant's six main pumps. The layout of the NEWPCC drywells and main pumps is shown on the attached figure.

The 36-inch diameter pump suction gate valve had been closed and a 12-inch diameter pump inspection plate had been loosened previously. The liquid behind the loosened plate had stopped draining. The operator jiggled the plate, and it started draining again. The operator backed off the nuts on the inspection plate to loosen it further and improve the drainage, intending to leave it until the draining stopped. Suddenly, the inspection plate ejected, and sewage escaped, rapidly flooding the 3 interconnected drywells with sewage. The power was turned off, preventing further serious equipment damage, and no one was seriously injured. However, this incident put the plant out of service. Establishing the cause of the incident will require inspection of the MP5 suction valve.

The Water and Waste Department is continuing to investigate the incident. In addition, the Department has engaged a consultant-engineering firm to design works to isolate the 3 pump wells so that a similar incident will not re-occur. These works will be implemented as soon as possible.

Also, the consultant-engineering firm is designing a process to isolate the east suction header while maintaining the plant in operation, in order to permit inspection of the suction valves and removal of the MP5 valve. This valve is sealed in order to assure it’s position at the time of the incident, and will not be disturbed without witness by environmental authorities. The City will be notifying the authorities in advance of this operation. Following this procedure, staff will be isolating the west suction channel and inspecting the pump suction valves on that side.
