January 2018

## Lake Winnipeg East System Improvement Transmission Project: Aquatics Monitoring - Summer 2017 Watercourse Crossing Report and Monitoring Conclusions

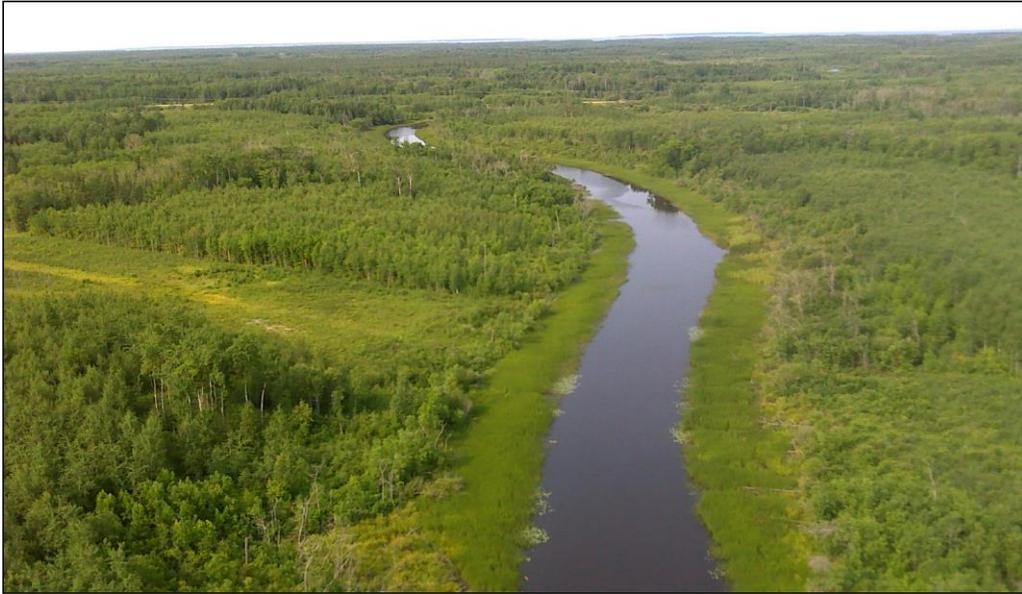
All of the sites observed were cleared, constructed and cleaned up in accordance with the mitigation measures outlined in the EnvPP, and the crossing and site conditions met the EnvPP and EAL requirements. Photographs 1 and 2 provide examples of the conditions observed along the project Right of Way (RoW) at watercourse crossing sites during the 2017 field survey.

Photograph 1: View looking east of the crossing at the Black River (LWE-Aqua-108) showing the preservation of the riparian zone and regrowth of vegetation along the RoW, July 20, 2017.

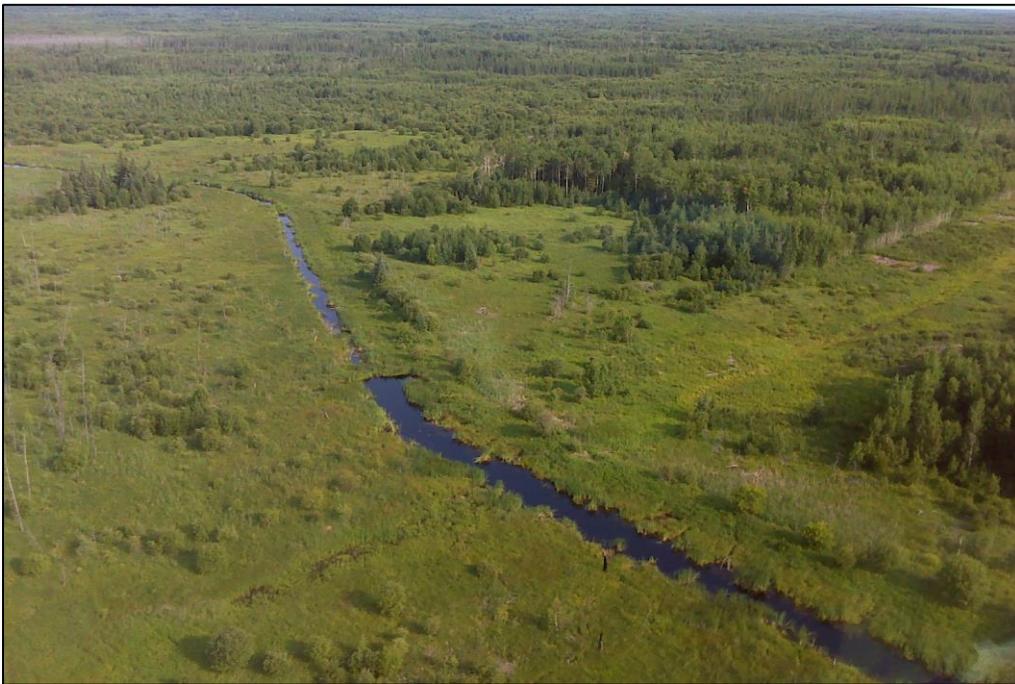
Photograph 2: View looking west of the crossing at an Unnamed Drain (LWE-Aqua-107) showing the preservation of the riparian zone and regrowth of vegetation along the RoW, July 20, 2017.

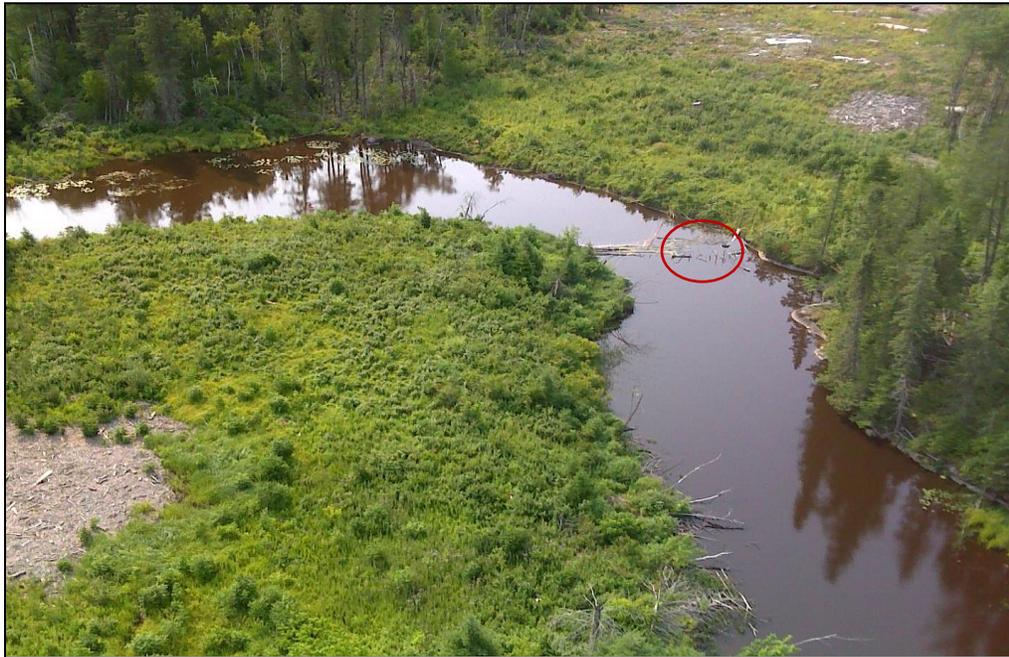
At Site LWE-Aqua-114, the O'Hanly River, there was an observation of a black rubber tire caught in woody debris on the surface of the river (Photograph 3). This site was ranked as having a perennial flow regime and categorized as having important habitat for fish (Miette 2012). The woody debris present in the watercourse was considered to be part of natural riverine processes and not due to construction activities. The tire and instream debris did not appear to be affecting the water flow in the river. This site could be revisited to remove the tire, if this action is considered to be necessary.

Photograph 3: View looking south of the watercourse crossing site at the O'Hanly River (LWE-Aqua-114), July 20, 2017. The red circle shows the location where the tire was caught in the woody debris.

In 2017, at Site LWE-Aqua-114, the O’Hanly River, there was an observation of a black rubber tire caught in woody debris on the surface of the river. The woody debris present in the watercourse was considered to be part of natural riverine processes and not due to construction activities. The tire and instream debris did not appear to be affecting the water flow in the river. This site could be revisited to remove the tire, if this action is considered to be necessary.

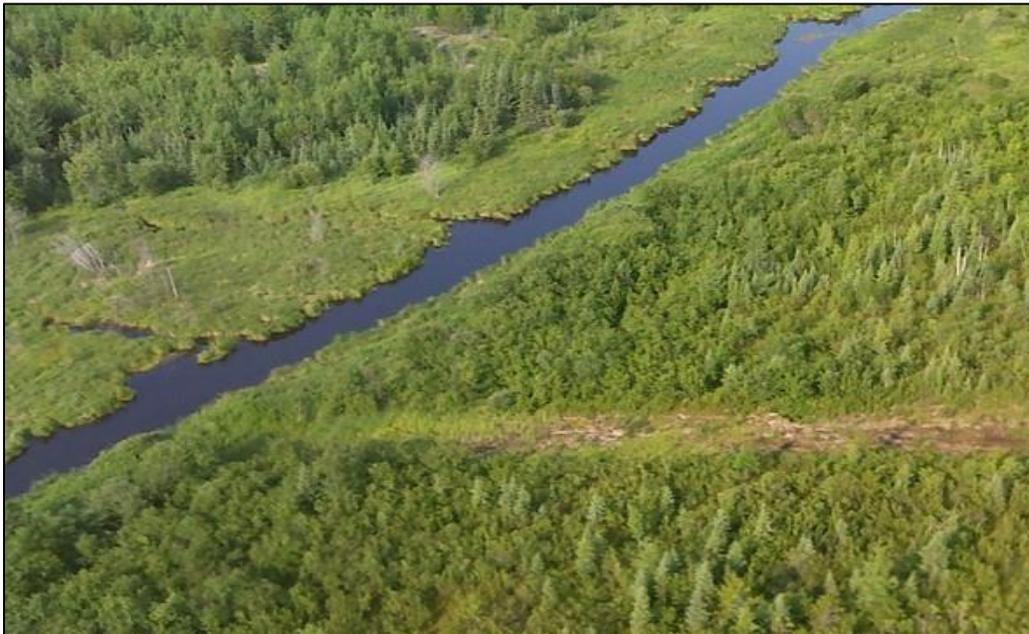
Site LWE-Aqua-103 (referred to as Site 16 in Miette 2012) is an Unnamed Drain located between the Sandy River and Duncan Creek that was ranked as having an intermittent flow regime and categorized as having marginal habitat for fish (Miette 2012). During the 2016 field survey, it was noted that clearing had taken place up to the water's edge on the north side of the crossing, and there were remnants of silt fencing material and straw erosion control blanket/matting on the north bank of the crossing. There were no indications of erosion or sediment control issues at the site; the banks were stable with no exposed areas of soil and there was no slash or debris in the watercourse or any disruption in water flow noted during the 2016 field survey.

This site was revisited in 2017; the silt fence materials had been removed and there were no exposed areas of soil observed at the crossing (Photograph 4). Further regrowth of vegetation had occurred to the water's edge and the banks appeared to be stable (Photograph 4). As such, no further follow-up at this site was required.

Photograph 4: View looking west of the watercourse crossing site at LWE-Aqua-103, July 20, 2017.

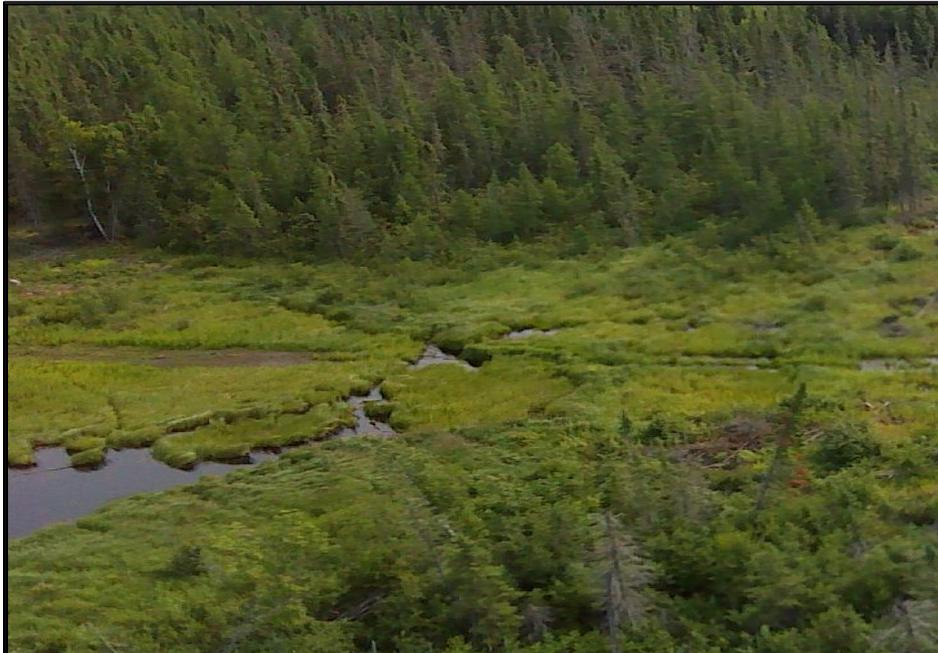
Site LWE-Aqua-113 (referred to as Site 8 in Miette 2012) is an Unnamed Drain located north of the O'Hanly River that was ranked as having an intermittent flow regime and categorized as having marginal habitat for fish (Miette 2012). During the 2016 field survey, it was noted that clearing on the south side of the crossing had been completed in accordance with the EnvPP but it appeared that machinery may have entered the 7m "No Machine Zone" at the north side of the crossing. There were no areas of exposed soils observed during the 2016 field survey that could potentially release or transport sediment or debris to the watercourse.

This watercourse crossing site was revisited in 2017; further regrowth of vegetation had occurred to the water's edge and the banks appeared to be stable (Photograph 5). As such, no further follow-up at this site was required.

Photograph 5: View looking east of the watercourse crossing site at LWE-Aqua-113, July 20, 2017.

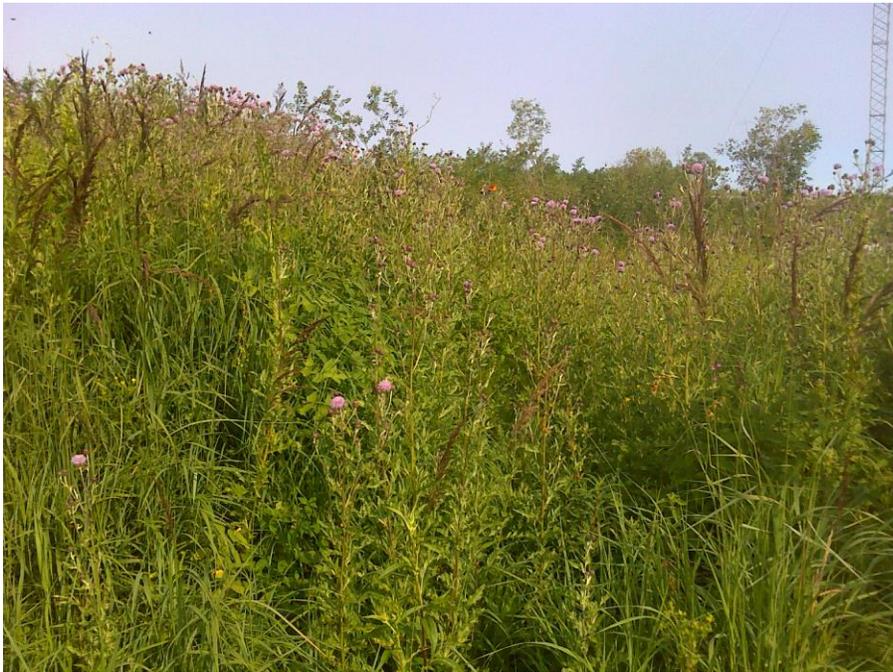
Although monitoring for invasive plant species is not part of the aquatics component of the LWESI Transmission Project Monitoring Program, it was noted that Canada thistle (*Cirsium arvense*), field bindweed (*Convolvulus arvensis*) and white sweet clover (*Melilotus albus*) were present within the riparian zone vegetation at LWE-Aqua-104 (Photograph 6, Photograph 7).

Photograph 6: View of Canada thistle in the riparian zone at LWE-Aqua-104, July 20, 2017.

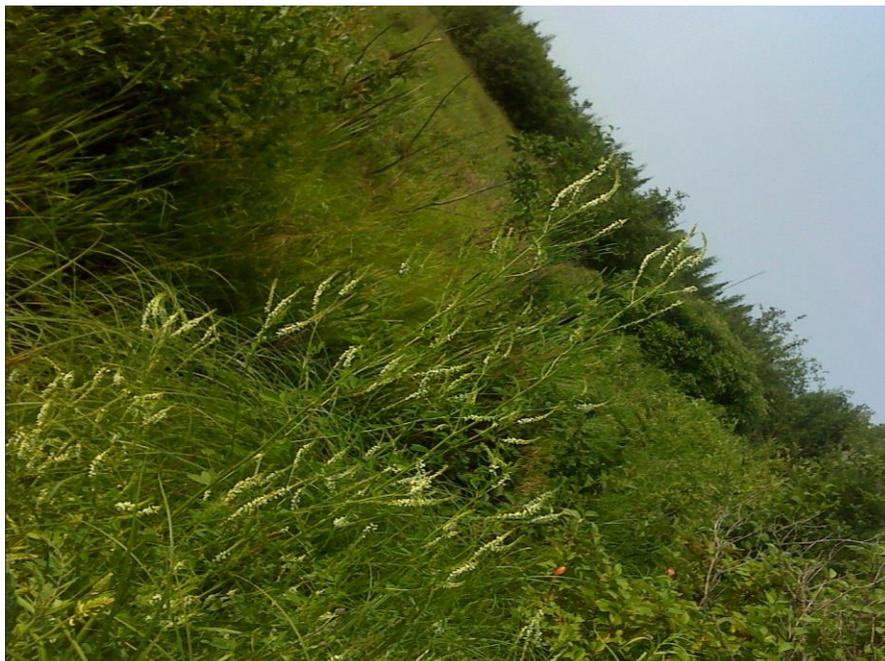
Photograph 7: View of white sweet clover in the riparian zone at LWE-Aqua-104, July 20, 2017.
