**MANITOBA - CANADIAN MODEL AQUA-FARM
INITIATIVE
PERFORMANCE MONITORING & MANAGEMENT**

Final Report

**Inter-Provincial Partnership for
Sustainable Freshwater Aquaculture Development**

March 2018

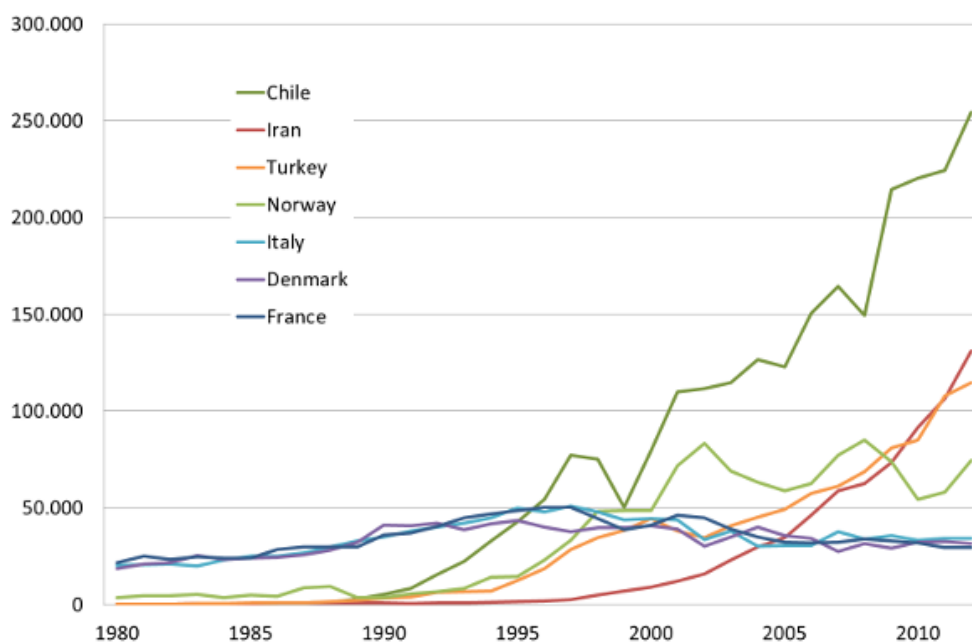
Figure 1: FAO statistics for annual trout production by country².

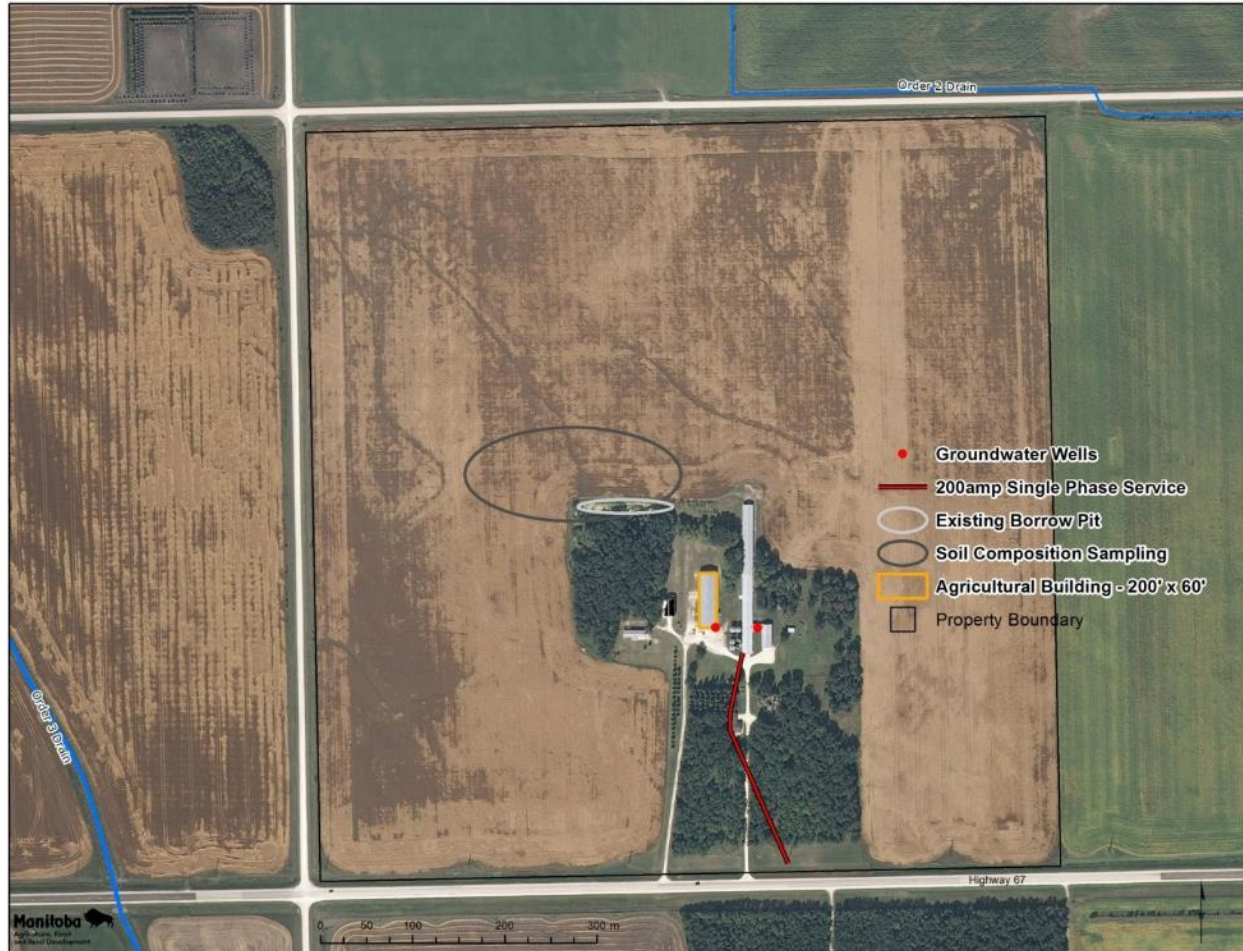
Figure 2: Aerial view with site assessment features for SW 25-13-1W, the site of the Manitoba – Canadian Model Aqua-Farm Initiative.

Regional drainage officers with the Manitoba Government were consulted to understand the general requirements to secure a discharge permit for the proposed aquaculture operation at this site. The Grassmere Creek watershed slopes gradually downward northwest to southeast flowing eventually into the Red River just north of the City of Winnipeg, draining an area of roughly 479 square kilometers. Municipal and provincial drains run directly along the northern and western sides of the quarter section of land on which the farm is located. Therefore, two options existed for discharging treated effluent.

As the site is located near the headwaters of the watershed, both nearby drains are low order (3rd order to the west and 2nd order to the north), ephemeral drains which connect to higher order drains further downstream. As is the case in much of Manitoba and in particular in the Interlake Region, the slope of the Grassmere Creek watershed is gentle resulting in slow movement of waters through the system during the majority of the year (spring runoff and large storm events being relative exceptions). For these reasons as well as the fact that treated effluent would need to flow through several culverts to reach non-ephemeral portions of the watershed, it was determined that treated effluent could not be discharged from the site on a year-round basis. Infrastructure would need to be put in place to facilitate effluent storage and subsequent discharge during summer and fall months following spring runoff and prior to freezing conditions. Being relatively flat, the natural topography of the site would not accommodate effluent storage by devoting a low area for water storage. Adequate effluent storage would require excavation of a purpose-built facility.

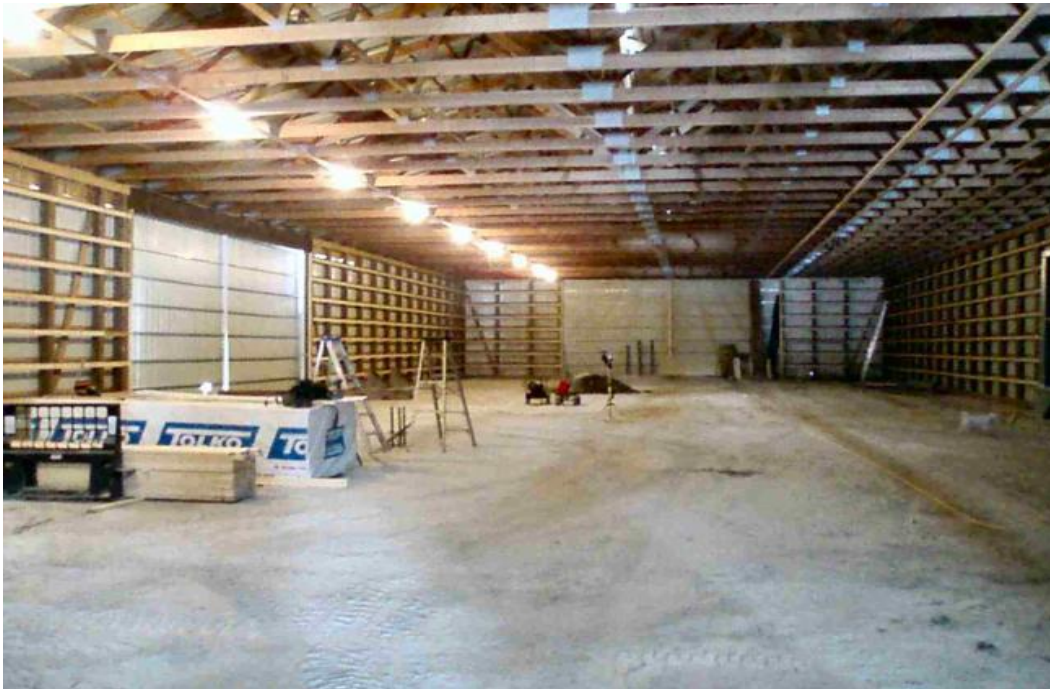
Figure 8: View of the inside of the barn being prepared for the installation of an encapsulated polystyrene insulation with reflective backing.

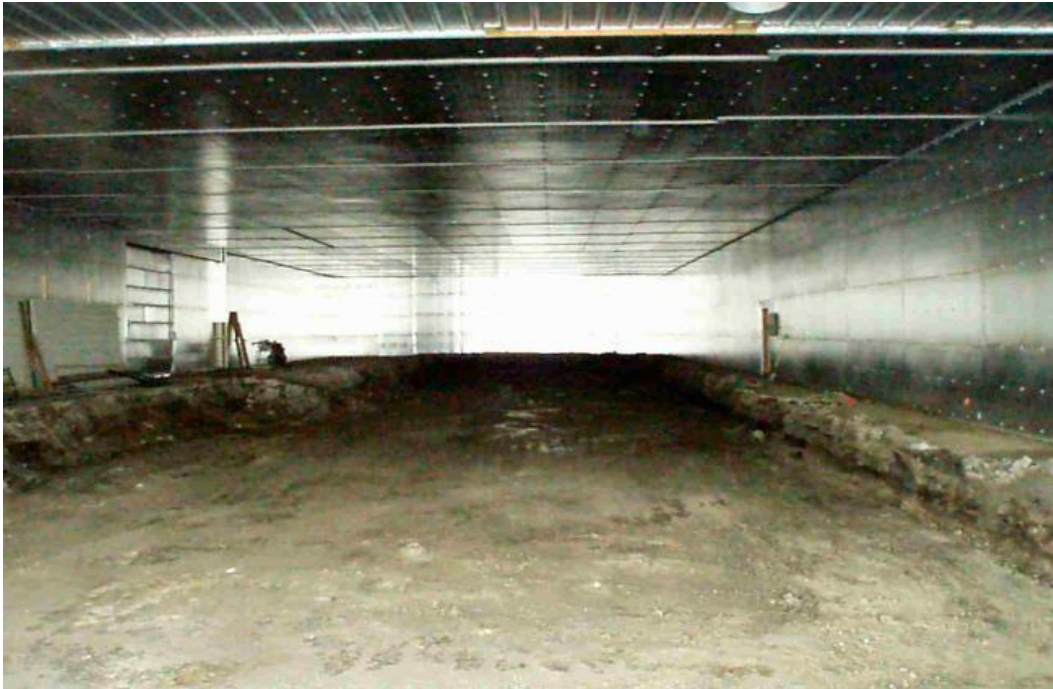
Figure 9: View of the inside of the barn following the installation of insulation and the beginning of earth floor excavation.

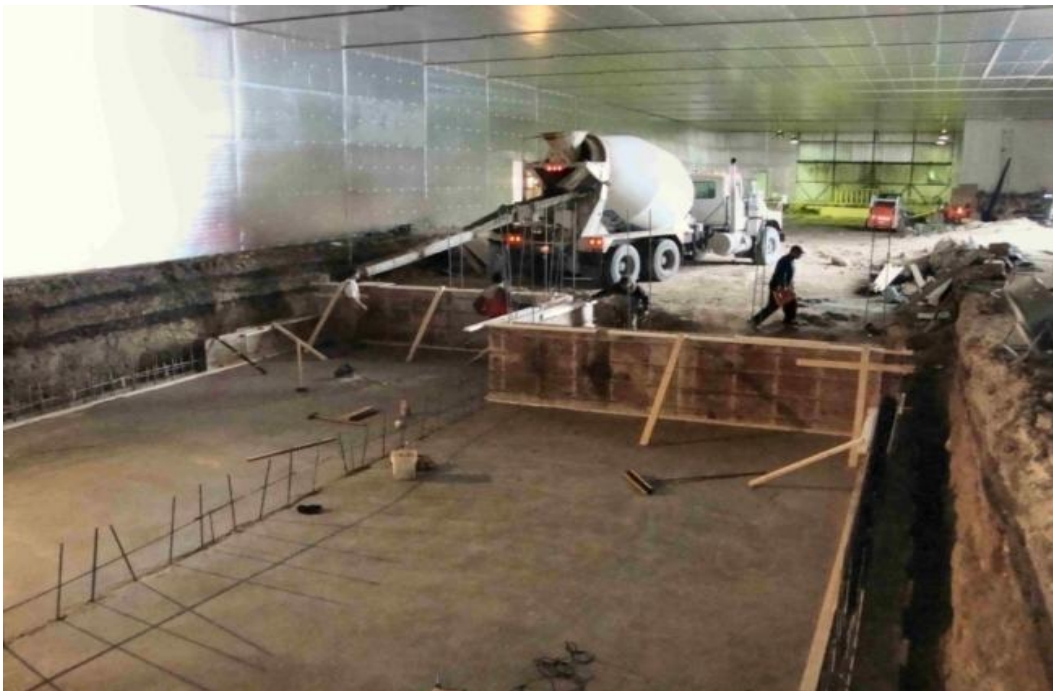
Figure 10: View of the first stage of concrete pouring. The first concrete that was poured was the floor of the water reconditioning system that sits approximately 7 feet below grade.

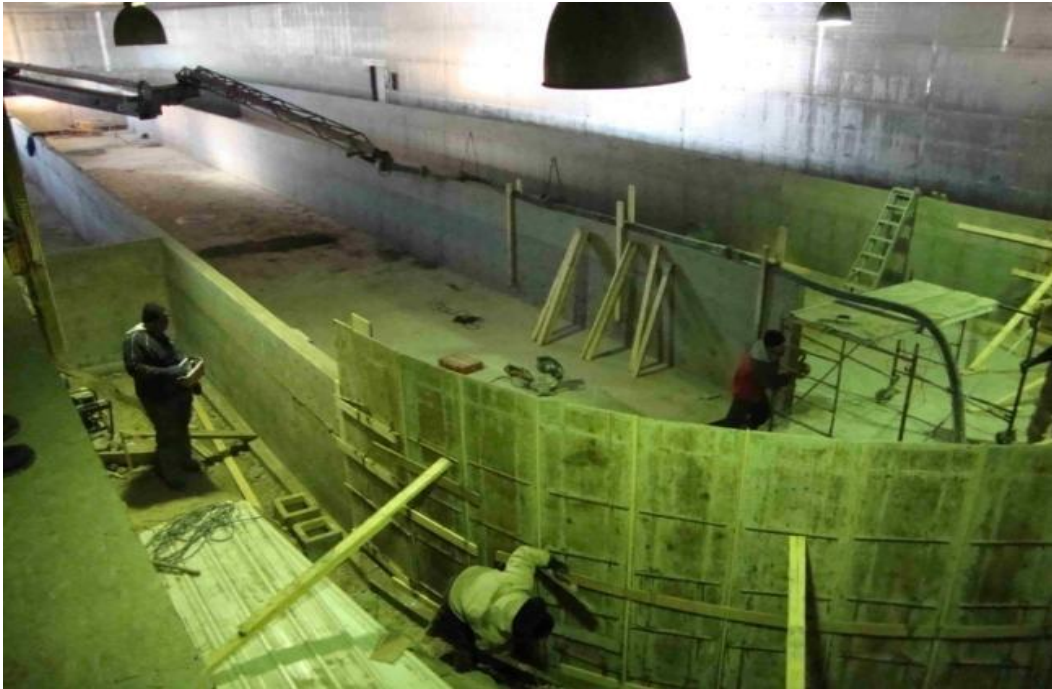
Figure 11: View of the construction crew pouring concrete into wooden forms used to construct the tank walls.

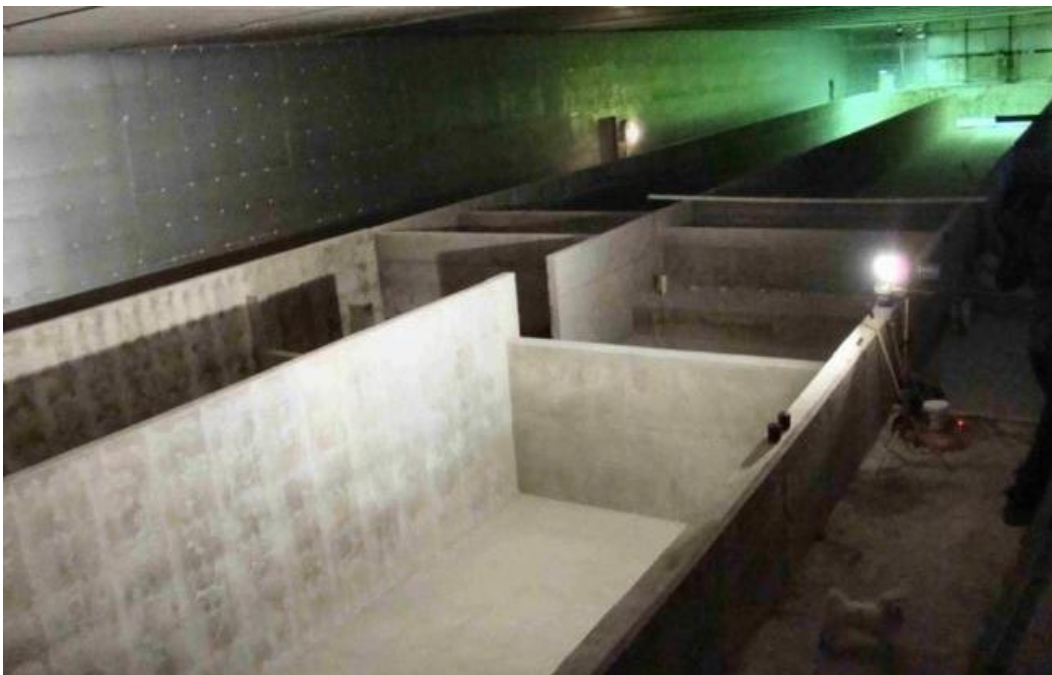
Figure 12: View of the completed concrete walls of the water reconditioning system.

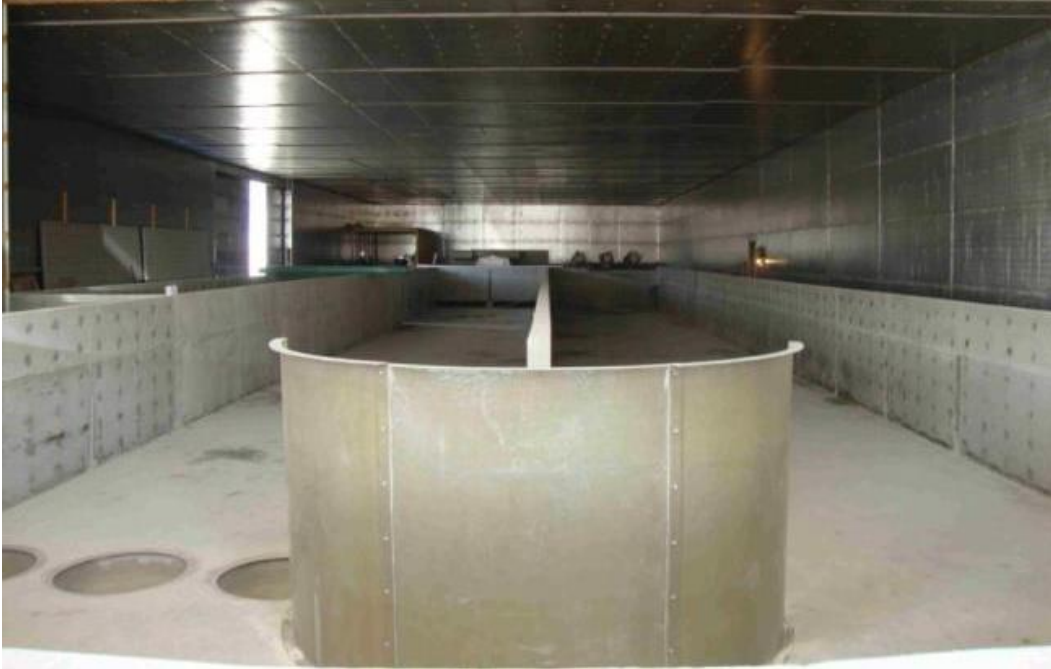
Figure 13: View of the production raceways where fish will be housed including fiberglass components such as the internal curved wall to help divert flow around the D-end as well as the upstream sludge cones that are cast into the tank floor.

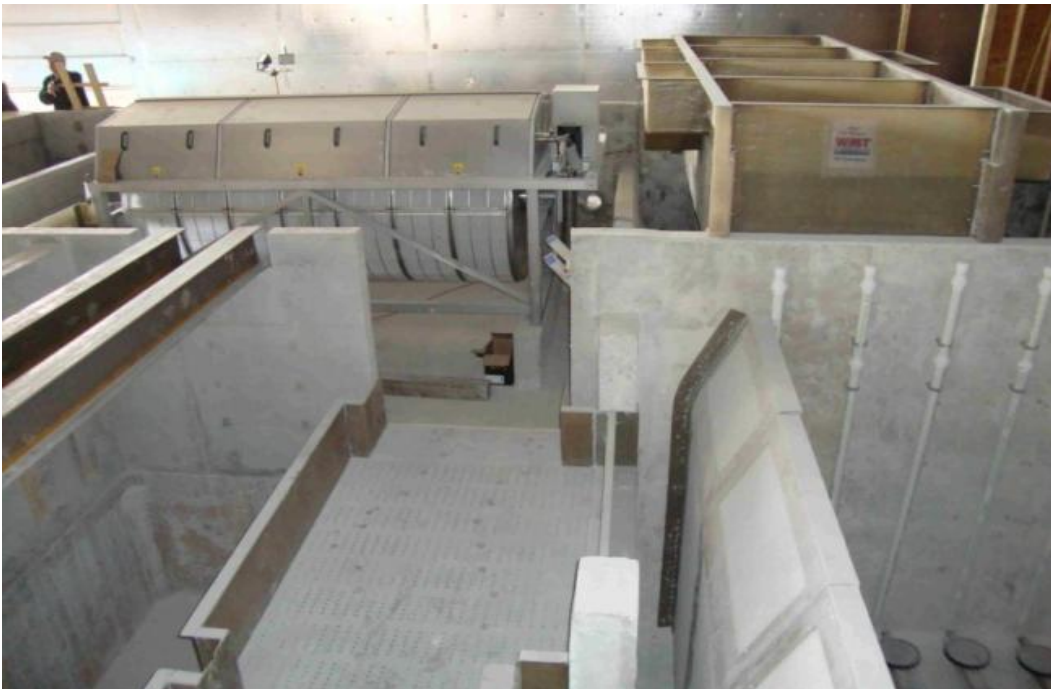
Figure 14: View of various installed components of the water reconditioning system. Namely: The LHOs, media retention screen and aeration grids in the foreground and the rotary drum filter and CO₂ strippers in the background.

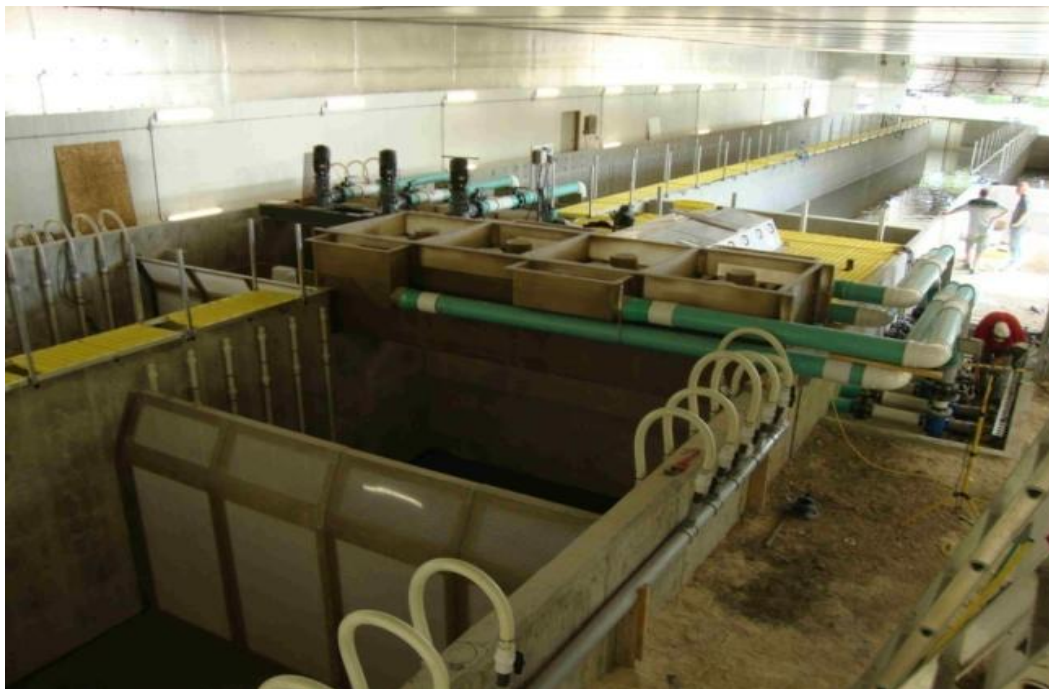
Figure 15: View of the production system with most system components installed including the over-tank walkways.

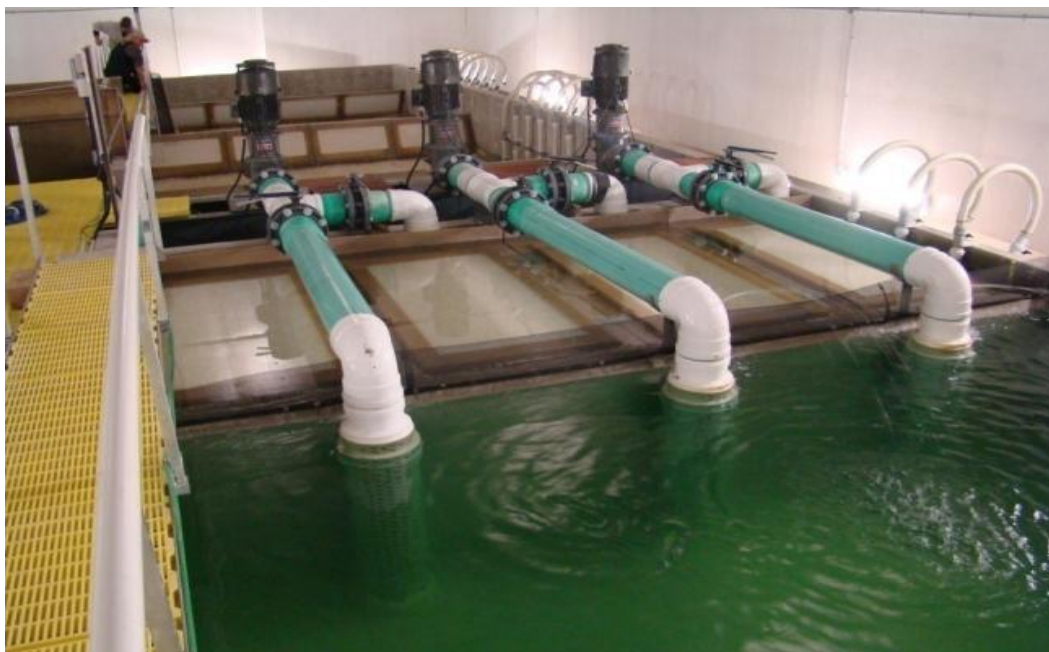
Figure 16: View of the main circulating pumps and fixed bed biofilter. Valves allow for the adjustment of flow through the fixed bed biofilter. Flow diffusers can be seen under water that help to reduce turbulence at the head of the production tank.

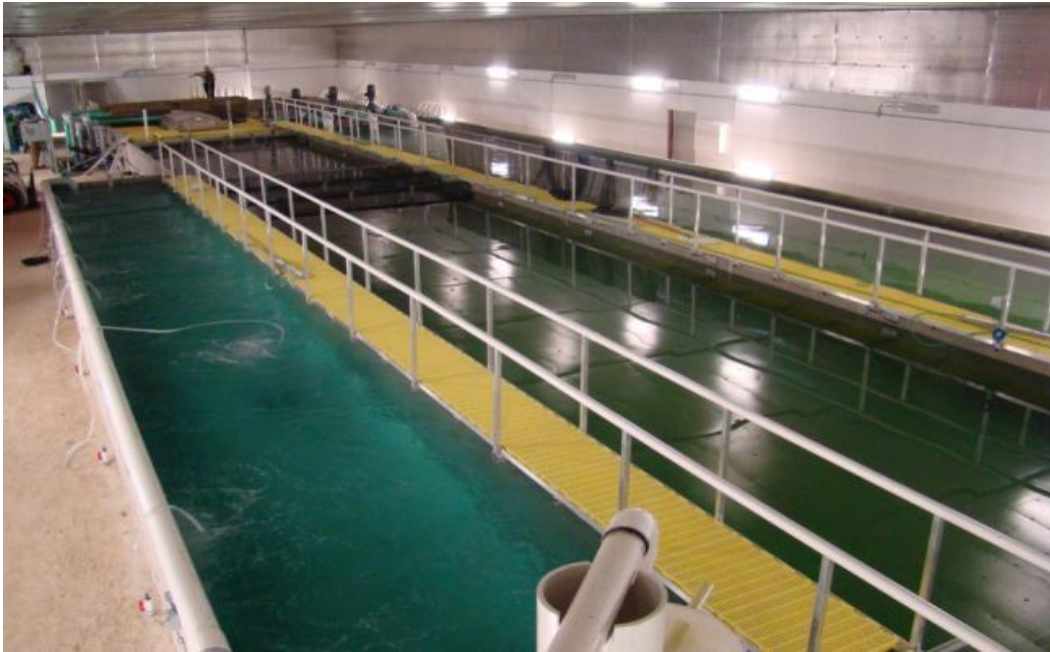
Figure 17: View of the production raceways and purge tank (on the left) with the incoming well water line in the foreground.

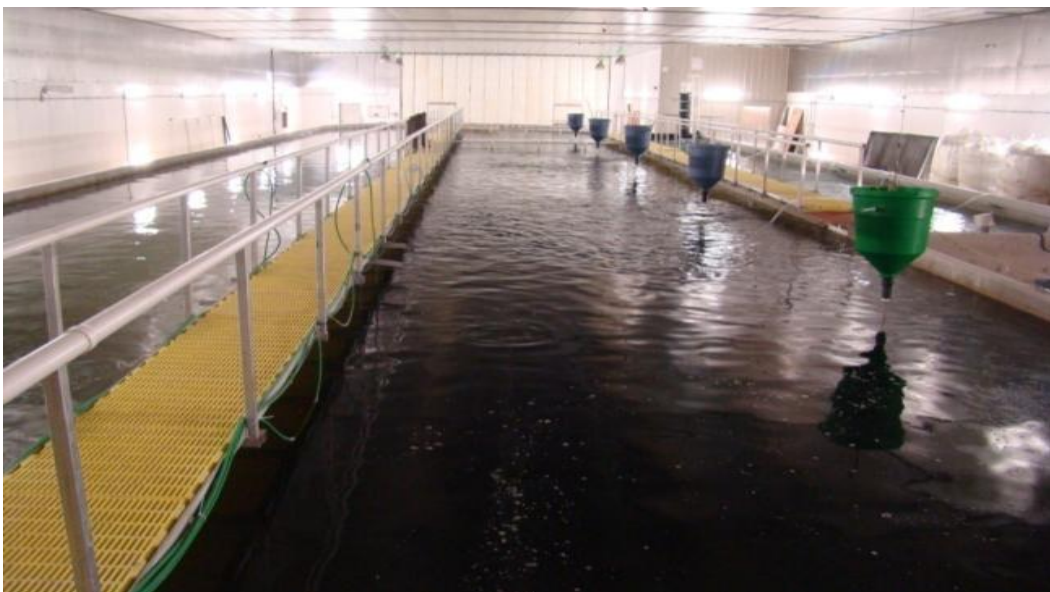
Figure 18: View of the production raceways and pendulum demand feeding system.

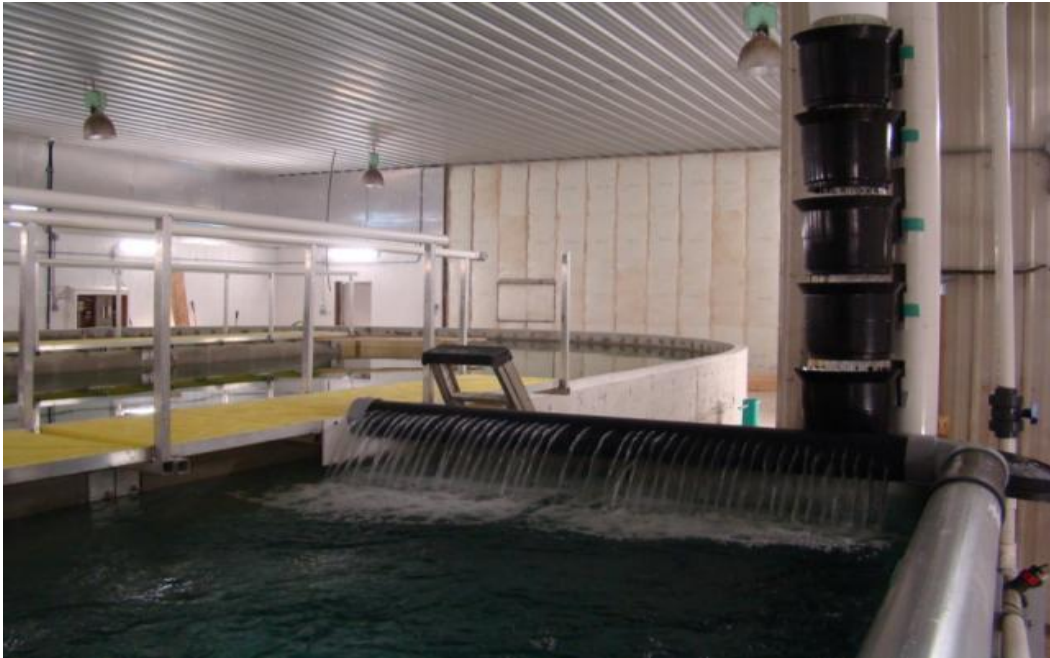
Figure 19: View of the head of the purge tank as well as the incoming well water cascading down through the degassing tower and the purge tank recirculation line below.

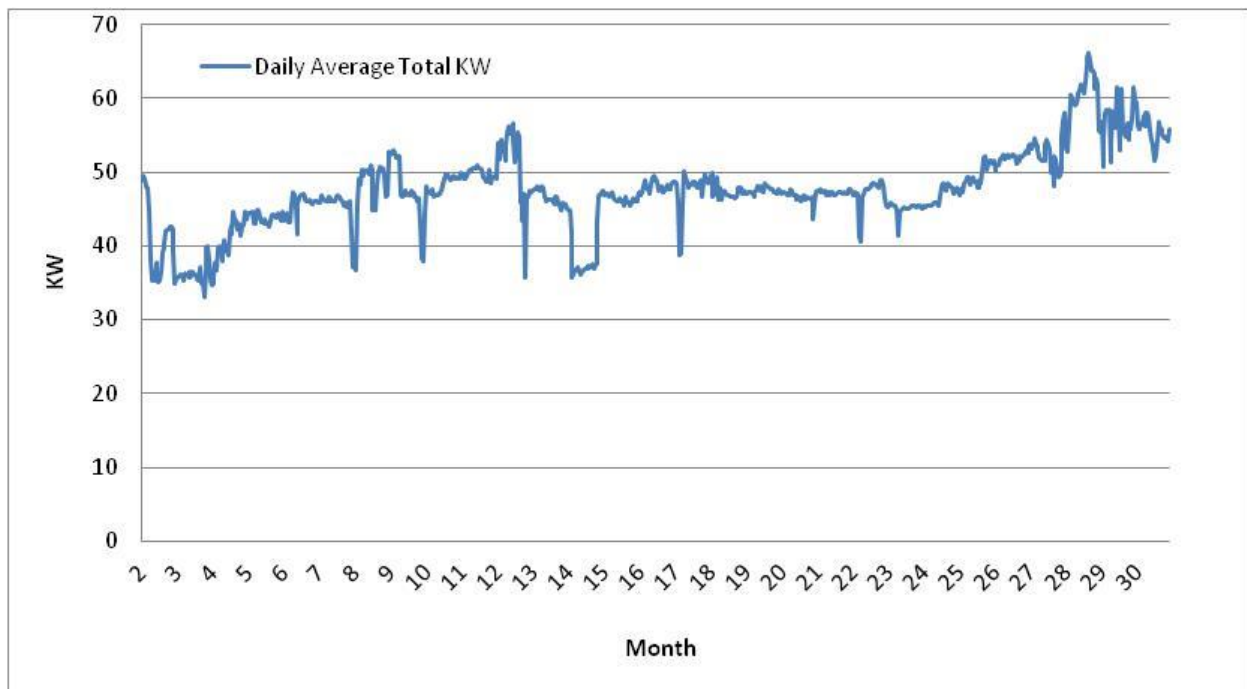
Figure 23: Total electrical consumption (kW) at the Manitoba - Canadian Model Aqua-Farm during the 30-month monitoring period.

Over the 30-month monitoring period, the farm utilized a daily average of 47.5 kilowatts (kW), with a range from 33.0 to 66.1 kW. During peak operations, the typical draw was between 45 and 50 kW with a median draw of 47.3 kW. A graph illustrating the continuous electrical use at the operation is presented in Figure 23.

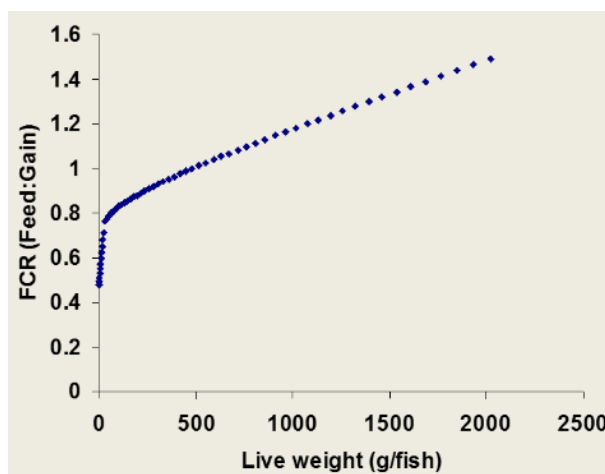
Figure 25: Estimated evolution of feed conversion ratio of rainbow trout using a bioenergetics model. (Source: Bureau, D. The Case for Production Benchmarking and the Usefulness of Nutritional Models to the Aquaculture Industry, Presented at the Martin Mills Feed Forum, March 27, 2012).

It is important to recognize the difference in FCR for fish below approximately 1,200 grams and those above 1,200 grams. Dr. Dominique Bureau, a leading salmonid nutritionist, identified that the feed conversion efficiency in rainbow trout declines dramatically as the fish become larger (Figure 25). This is in relation to the physiology of protein deposition into muscle mass. As indicated in Figure 24, once rainbow trout attain a body weight of approximately 500 grams, feed conversion efficiency decreases steadily. For this reason, as well as market factors, in the design of the model farm initiative, the decision was taken to harvest fish at an average weight of 1,200 grams.

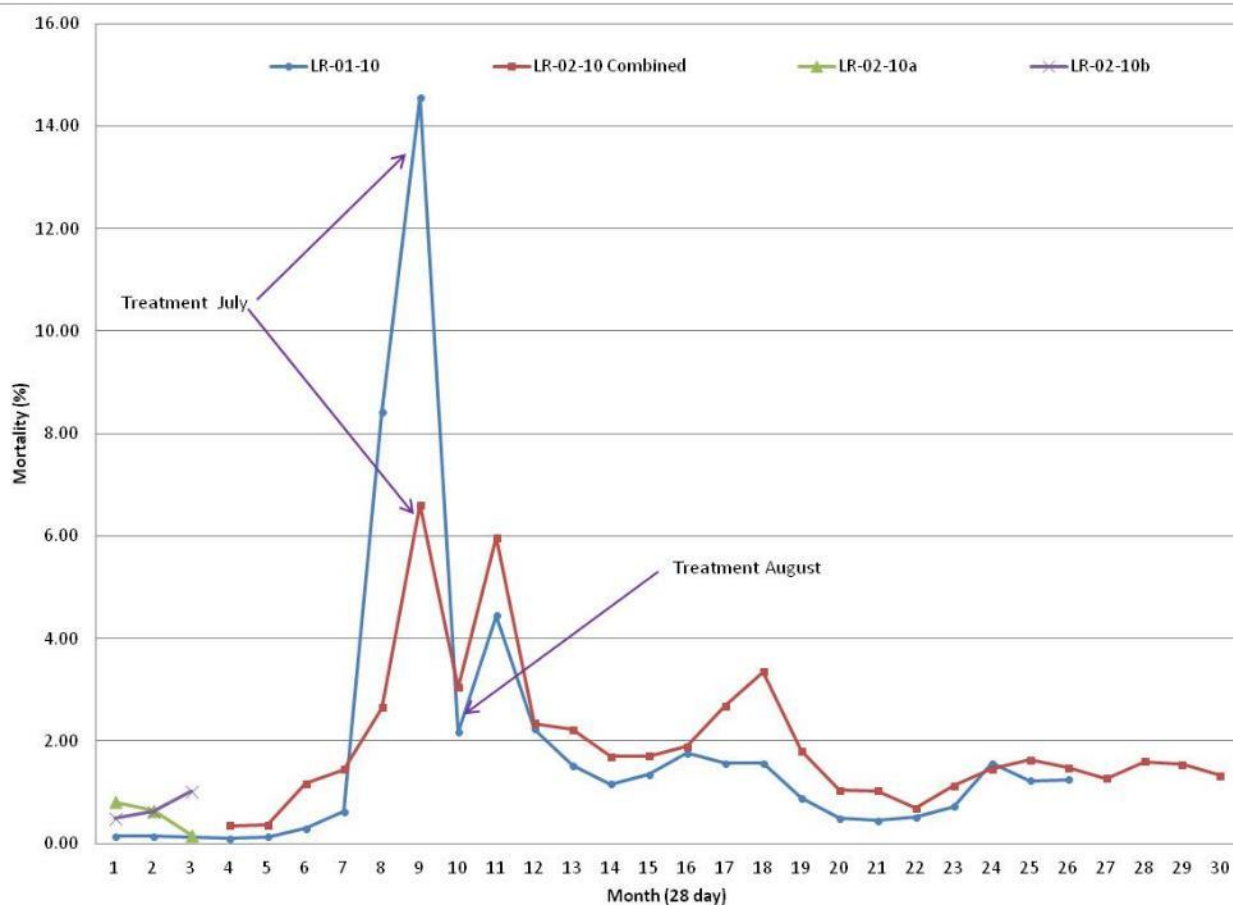
Figure 26: Monthly mortality of rainbow trout at the Manitoba - Canadian Model Aqua-Farm (% of total population)

Following chemotherapeutic treatments in months 8 and 9, mortalities declined through months 10 through 13, however, low-level mortalities persisted throughout the remainder of the production cycle at levels above expectation. For Cohort 1, the mortality rate ranged from 0.45% to 1.77% per month and for Cohort 2 it ranged from 0.69% to 3.35%. For fish of the size on hand, the expected monthly mortality rate is typically less than 0.25%.

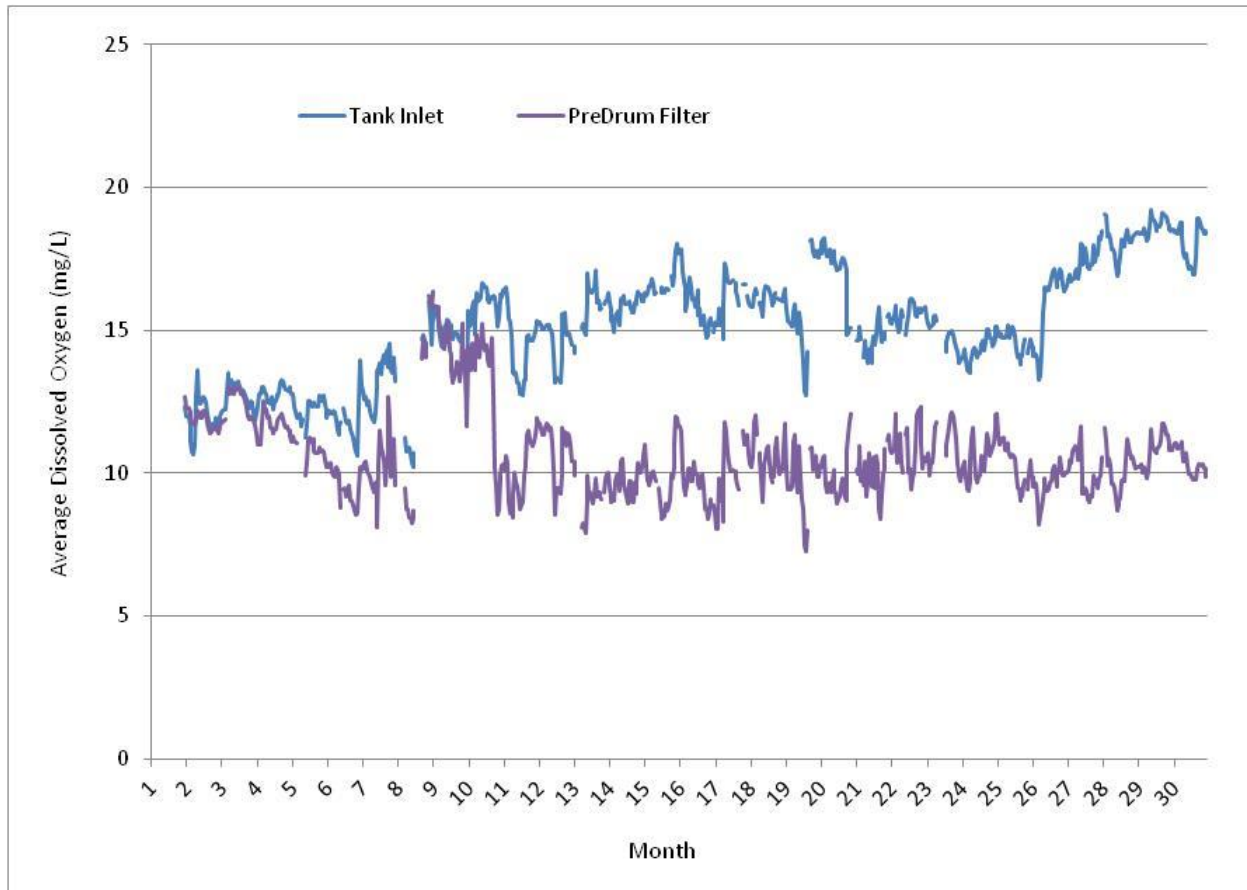
Figure 29: Concentration of dissolved oxygen in the rearing tank inlet and outlet throughout the monitoring period.

The delta-DO from the tank inlet to the tank outlet was nominal at the beginning of the production cycle as expected since the biomass loading, daily feed ration and oxygen consumption within the tank were low. As the biomass increased, the delta-DO increased proportionately. Toward the end of the monitoring period, the delta-DO averaged approximately 8 mg/L (Table 14, Figure 29).

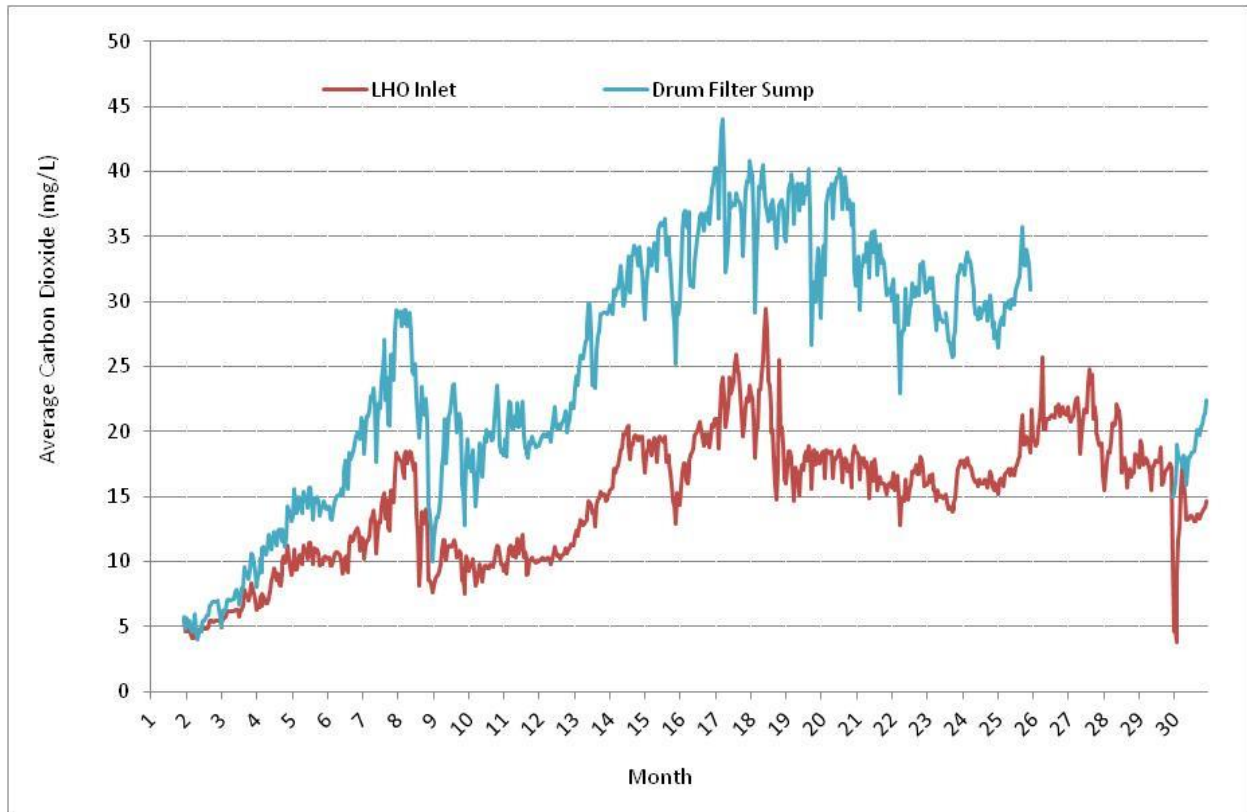
Figure 30: Concentration of CO₂ in the rearing tank inlet and outlet throughout the monitoring period.

It is important to note that the CO₂ stripper was designed and installed with passive air exchange ventilated into the production room. An exhaust fan ventilated the production area to the outdoors; however, the exhaust fan that was installed was under-sized to provide adequate ventilation for effective removal of CO₂ from the production room. The design included an option for forced-air ventilation with the air from the degasser discharged directly outside. When the CO₂ levels were observed to be above the target level, the recommendation was made to install the forced ventilation option, however, the original configuration was not changed throughout the monitoring period.

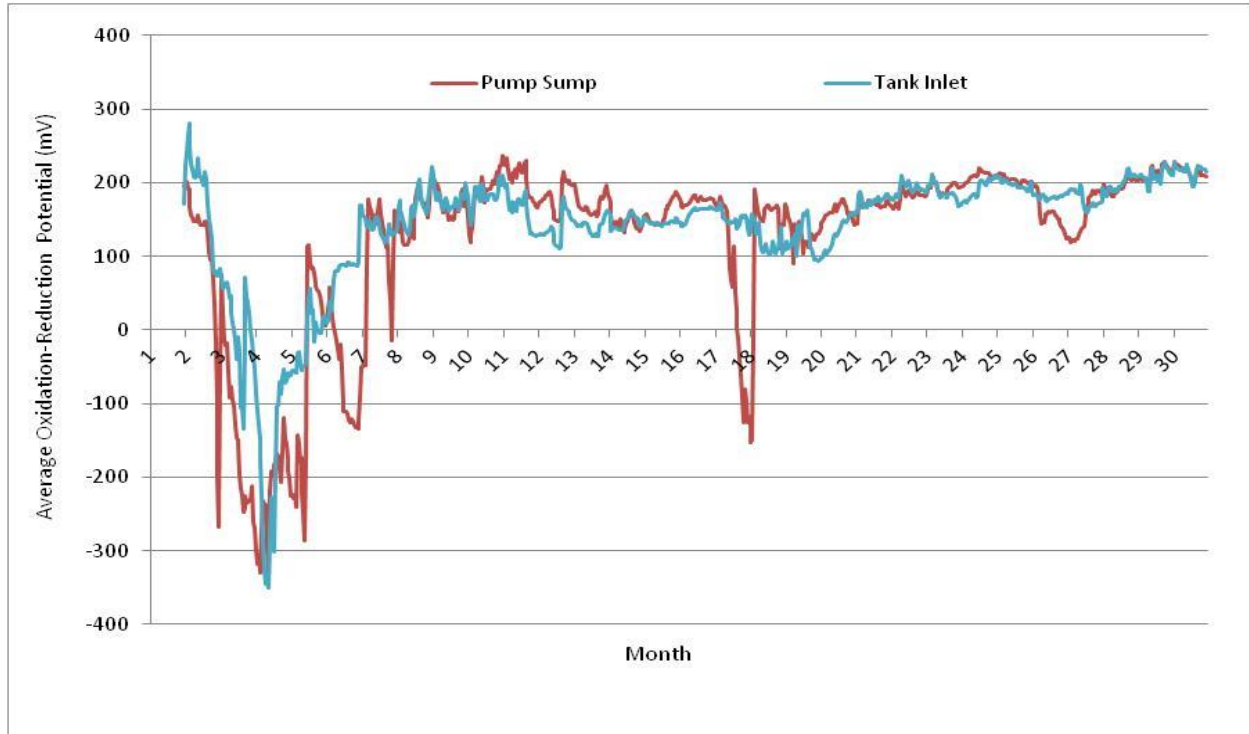
Figure 31: ORP levels in the tank inlet and outlet throughout the monitoring period.

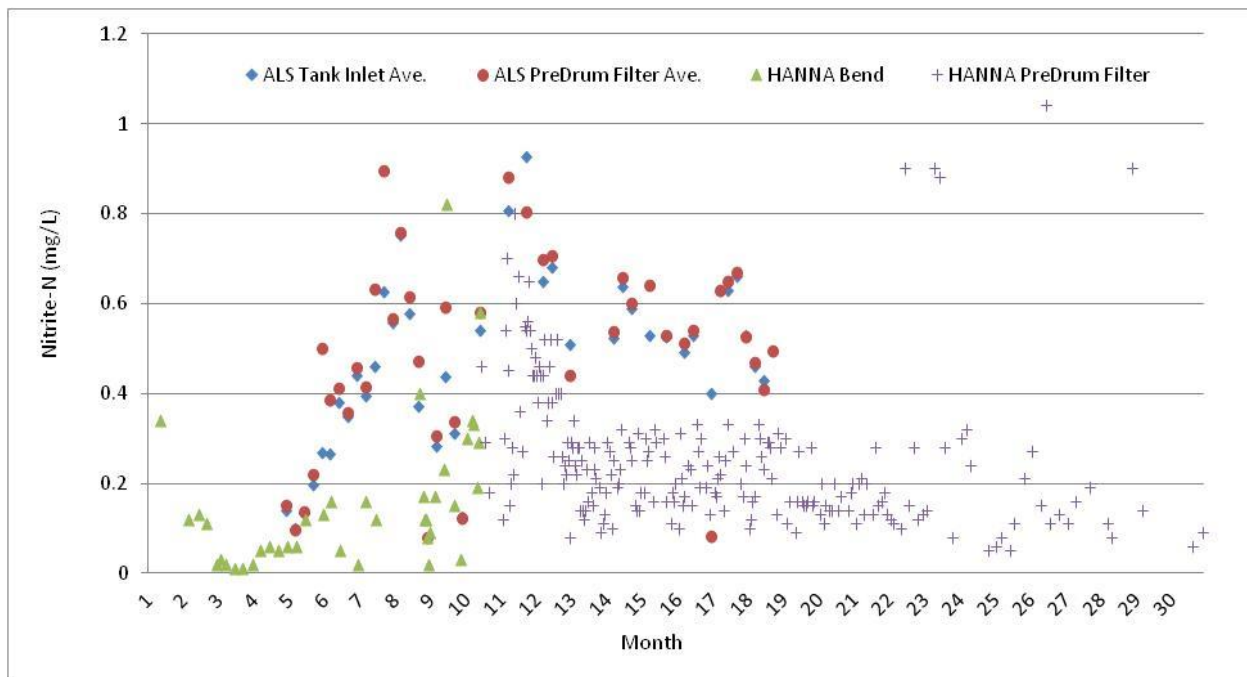
Figure 34: Concentration of nitrite (NO₂) in the system throughout the monitoring period.

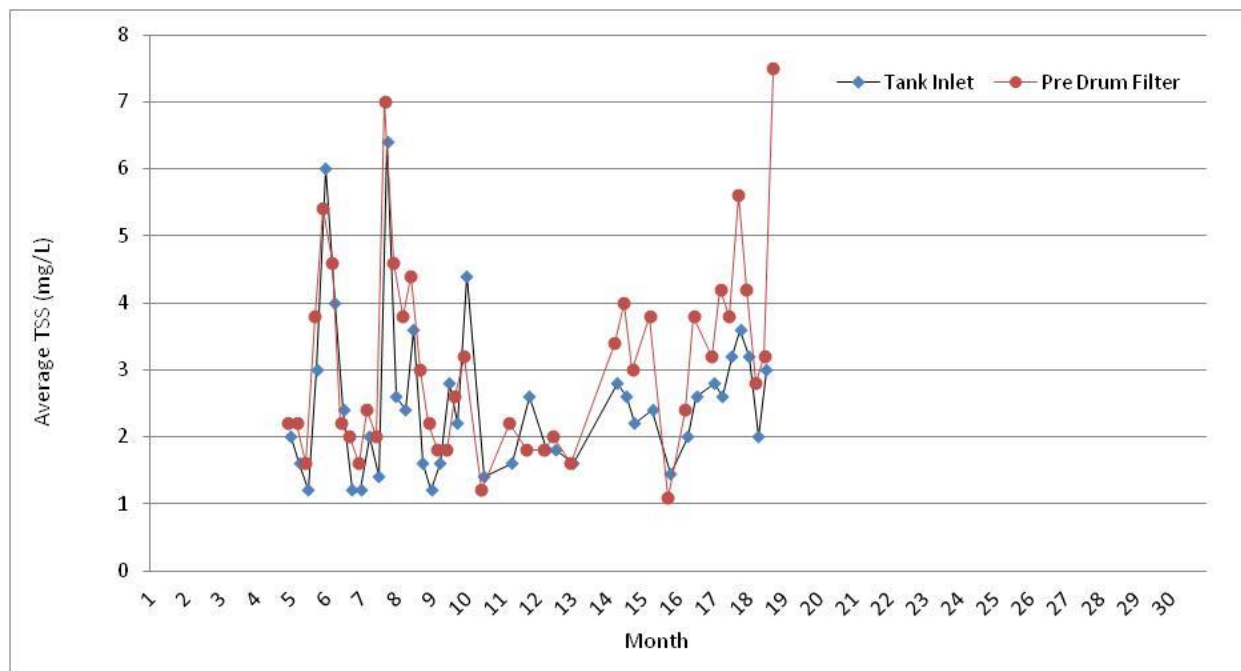
Figure 37: Concentration of total suspended solids in the rearing tank throughout the monitoring period.

The concentration of total suspended solids in the system was always less than 8 mg/L and averaged around 3 mg/L (Table 14, Figure 37). These data are well within the recommended range for salmonid fish.
