City of Winnipeg  
Water and Waste Department

# Combined Sewer Overflow Management Study

PHASE 3 Technical Memoranda

# 1996/1997 Floatables Capture Program

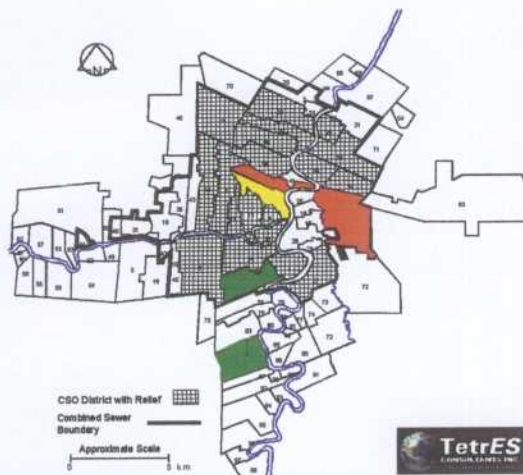
**Figure 1:** Relative locations of monitored outfalls. Collected floatable volumes were greatest in red areas, and least in green coloured areas.

Over two summer programs, 5 outfalls were monitored for floatables. Outfall locations are shown in Figure 1 and were selected as follows:

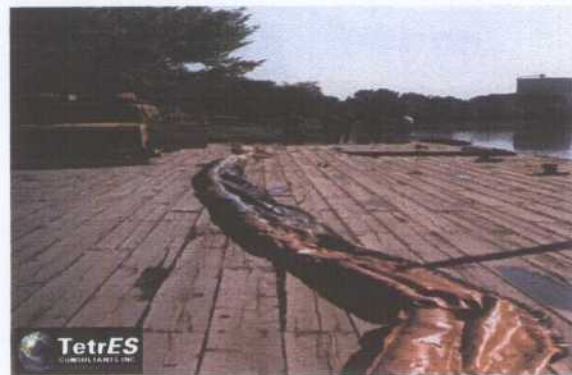
**Figure 2:** The boom is unrolled its full length prior to beginning the attachment of the boom mesh curtain and the mesh weights.

The assembly of the boom is a simple process requiring two workers and a minimum of handtools. The first step in the assembly process was to lay the boom out its full length along a convenient working surface. Boom assembly for the 1996 field program was conducted on the deck of the Alexander Docks. As seen in Figure 2, the boom was laid out its full length in order to simplify attaching the mesh and mesh weights. The mesh was fastened to the floating boom using plastic fastening ties.

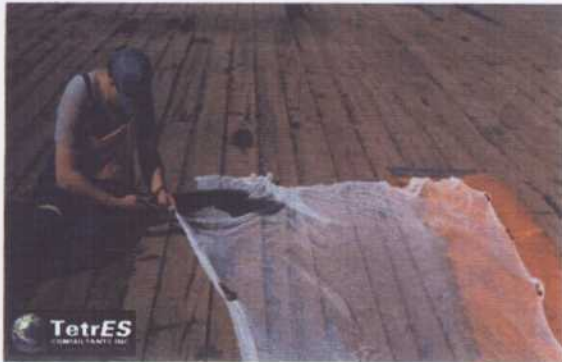
*Figure 3: Metal weights are secured to the bottom of the mesh net to keep the curtain in the desired position as it hangs suspended from the floating boom.*

Once the mesh is attached, metal weights are fastened to the bottom of the mesh curtain at regular intervals (Figure 3). The weights serve to keep the mesh curtain in a downward position as it hangs sus-

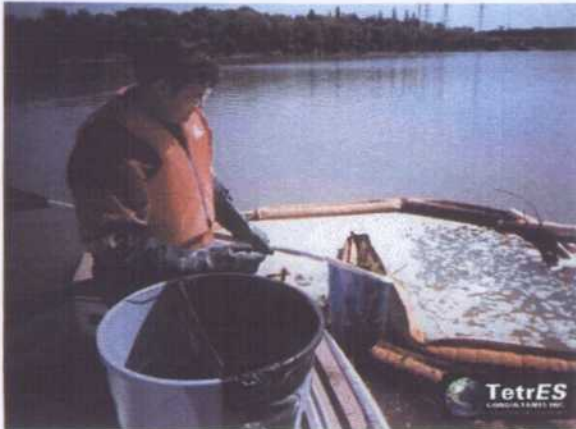
*Figure 5: Personnel dressed in protective clothing and gloves skim floatables collected within the boom after rainfall events.*

The floatables were collected from the boom using rakes and pool skimmers, placed in garbage bags, and placed in the boat. The crew returned to the Alexander Docks for characterization and measurement of the floatable material.

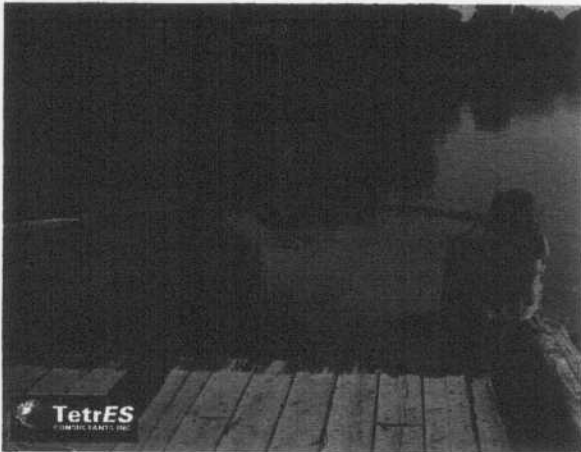
*Figure 7: The Alexander CSO Boom installation involved anchoring one end of the boom to the shore and the other end of the boom to the Alexander Docks.*

The first boom installation was located at the Alexander outfall. This outfall is situated within the core area, and was considered to have a representative distribution of residential/commercial/industrial land use. The boom as installed is shown in Figure 7.

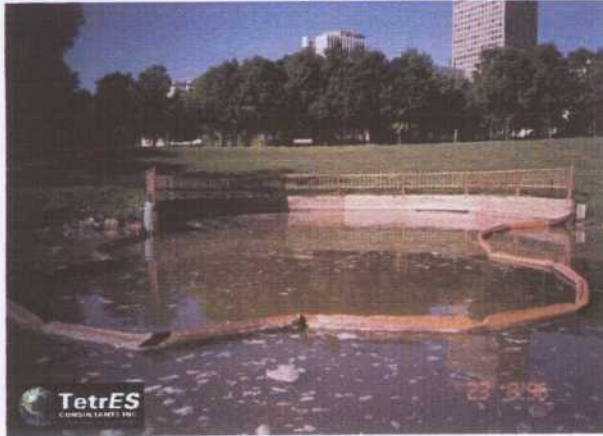
**Figure 8:** The Combined Sewer Outfall at Juba Park serves the Bannatyne Sewer District. The configuration of this outfall makes it an ideal location for boom installation.

wall with steel railing) which allow for easy anchoring of the boom during installation. Figure 8 shows the boom as installed at the Bannatyne outfall.

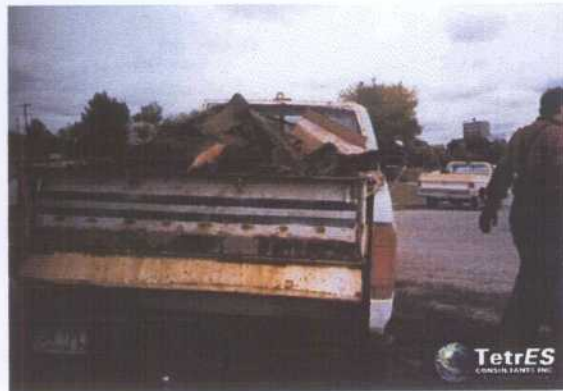
**Figure 9:** The boom and mesh netting fit easily in the back of a pickup truck. The boom is spray washed prior to storing over winter.

The boom fits easily within the bed of a regular City of Winnipeg pickup truck (Figure 9). A City of Winnipeg crew picked up the boom and drove it to a works yard where it was spray-cleaned prior to winter storage. The total time required to remove the boom and load it into the truck was approximately three-quarters of an hour.

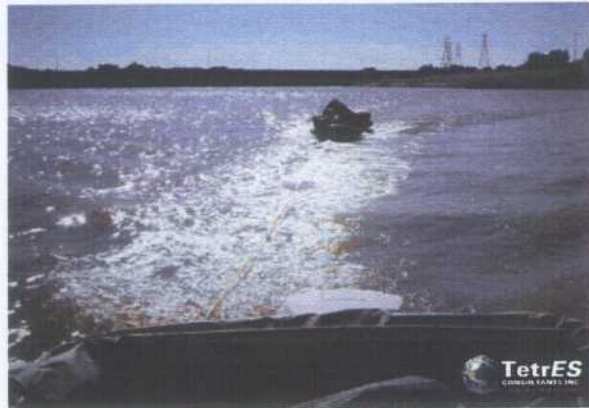
Figure 10: Moving the boom over longer distances was done by loading the boom in to a zodiac boat and towing it behind a speedboat.

loaded Zodiac was then towed by powerboat to the next boom installation site (Figure 10). This method provided effective, as it prevented the extra expense of a City truck and crew to assist in extracting the boom from the river, loading it onto a truck, and transporting the boom by road.

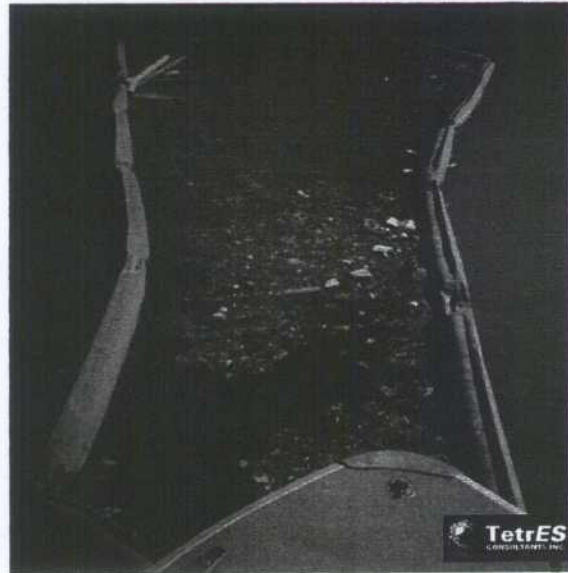
*Figure 11: The Mission outfall is located on the Seine River upstream of the Seine River / Red River confluence. In the photo above, debris and oils are trapped in the boom after a rainfall.*

The final boom installation site of the 1997 field program was the Mission CSO outfall (Figure 11). This large outfall is located upstream of the Seine River and Red River confluence.

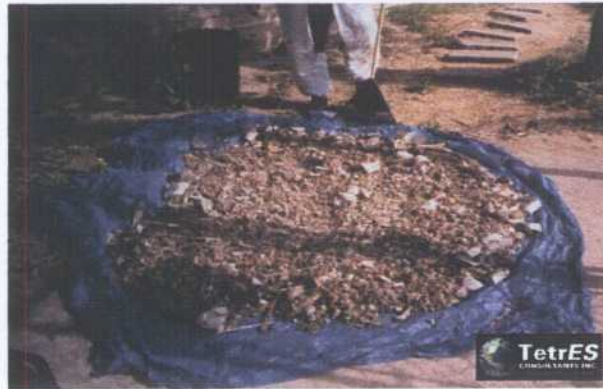
*Figure 12: The first boom installation at the Alexander outfall yielded significant volumes of captured floatables. After one rainfall, the boom at this location captured almost 80 pounds of floatable debris.*

While some outfalls were found to episodically introduce significant floatable debris loadings to the river subsequent to rainfall events (Figure 12), others were found to discharge very low quantities of debris. In some cases, debris was specific to individual industry sectors in the sewer district (such as animal processing plants).

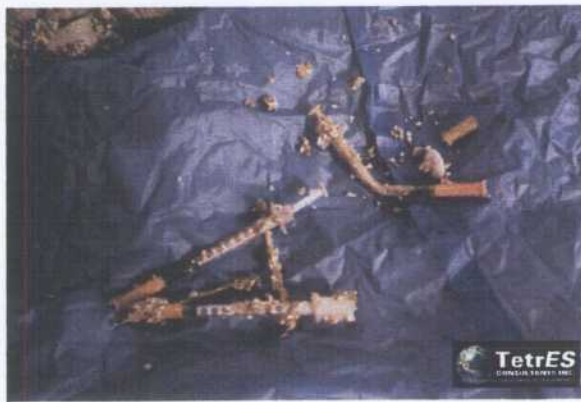
*Figure 13: Used hypodermic needles were routinely found in the captured floatable debris of one city outfall, the Alexander outfall.*

Based upon the observations obtained from the five boom installation locations thus far, it appears likely that floatable debris management and control on Winnipeg's rivers could be achieved through selective targeting of only the outfalls which have demonstrated problematic floatable debris loadings. The Alexander outfall was discovered to routinely discharge hypodermic needles subsequent to rainfall events (Figure 13).

Areas exist within the Alexander sewer district which have been associated with street activity such as prostitution and intravenous drug use. One possible source of the hypodermic needles found in captured floatables is the practice of drug-users discarding syringes from cars at curbside. The syringes would then be flushed into the combined sewer system with the street runoff following significant

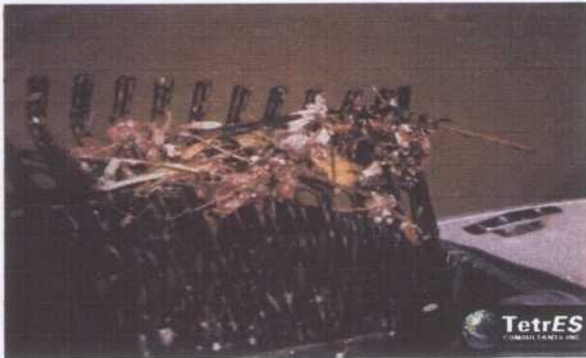
**Figure 14:** At the Mission outfall, one rainfall event resulted in the discharge of significant amounts of raw animal tissue. The animal tissue is seen as red material in the skimming rake pictured above.

The Mission outfall was discovered to discharge significant amounts of animal tissue after one rainfall event (Figure 14). The Mission outfall serves an area of the city which contains several animal processing industries. It is quite possible that one of these industries is not practising proper filtration of biological tissues prior to discharging their effluent into the city sewer system.

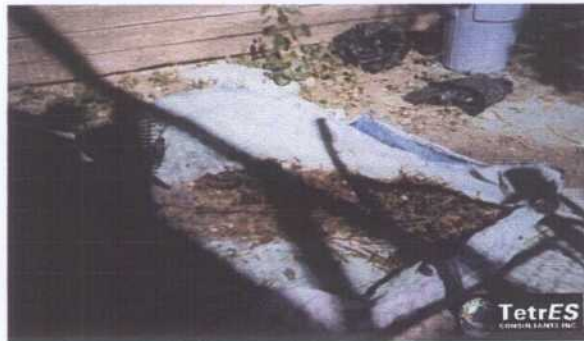
**Figure 15:** The Lot 16 Drain outfall was the only LDS outfall monitored in the floatables study so far. The largest component of captured floatables from this LDS was grasses and twigs.

Land Drainage sewers were found to discharge floatables, however the composition of the floatables was almost entirely natural debris (Figure 15).

Observations taken at the Lot 16 Drain LDS outfall suggest that floatable discharges from this source would not be aesthetically noticeable by users of the rivers. The largest component of floatables captured from the monitored LDS outfall was grasses and small twigs.

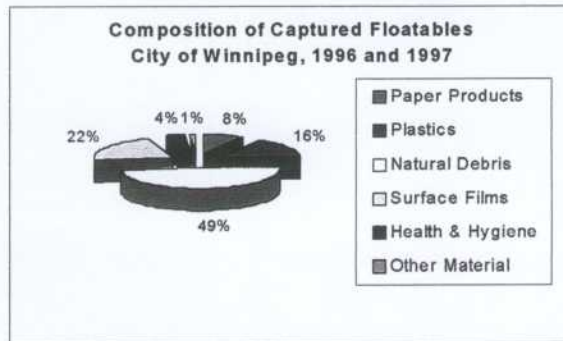
Figure 16: Composition of captured floatables at observed City of Winnipeg outfalls was mostly natural debris. Approximately 74% of captured floatables can be attributed to street litter.

Figure 16 shows the breakdown of average composition of captured floatables from outfalls discharging into the Red River. On average, natural debris is the main component of discharged floatables (49%) followed by surface films (22%), plastics (16%), paper products (8%), health & hygiene products (4%) and other material (~1%).

flushed down the toilet. The remaining component of floatable debris (approximately 74%) is attributed to street litter washing into the sewer system after rain events.
