Report on 2014 Artificial Flooding due to Operation of the Shellmouth Dam

July 7, 2015

Manitoba Infrastructure and Transportation

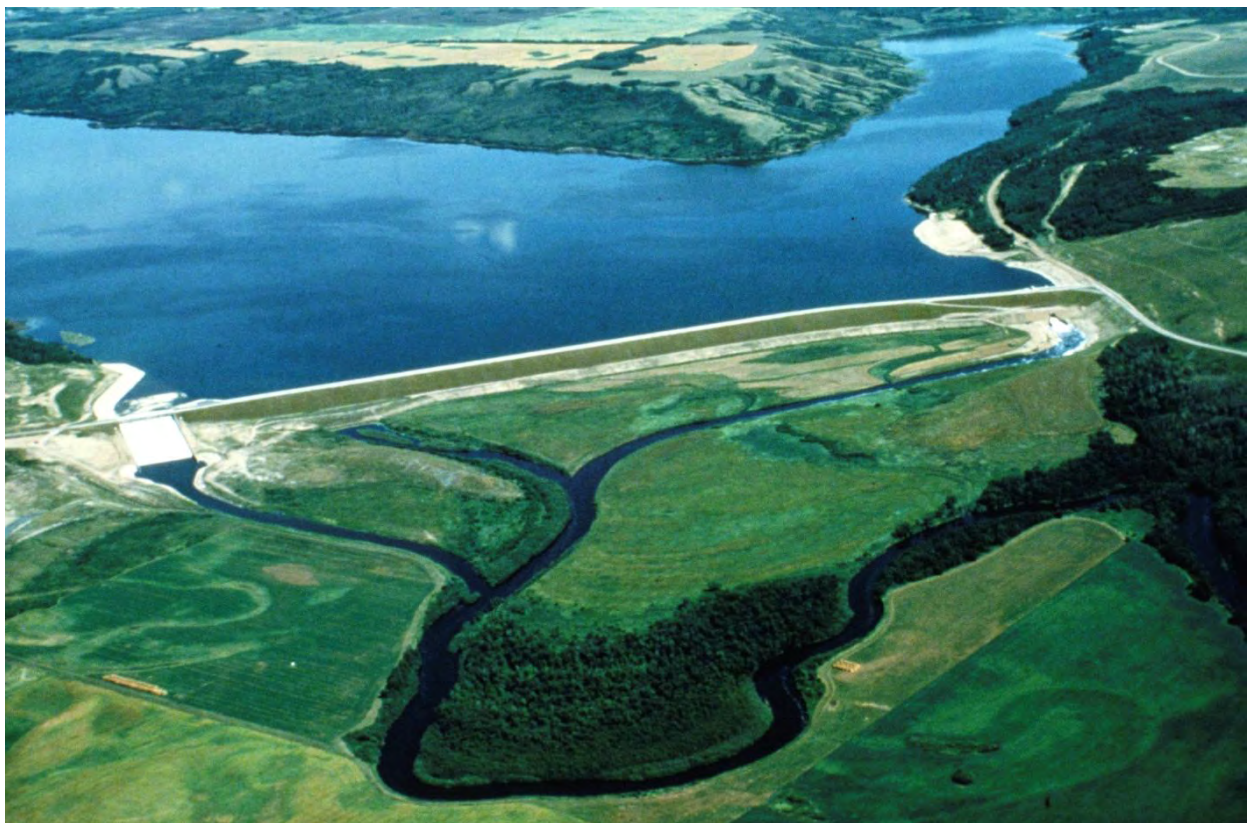
Figure 1: An aerial view of Shellmouth Dam and Reservoir (Lake of the Prairies) looking upstream. Upper right is the Shell River. The outlet is on the right hand side of the photo and the spillway is on the left hand side of the photo.

The dam is approximately 70 feet (21.3 m) high and has a crest length (length) of 4,166 feet (1,270 m). The facility includes a 15 feet (4.6 m) diameter reinforced concrete conduit for releasing flow from the reservoir and an ungated concrete chute spillway designed to spill water when reservoir levels are high.

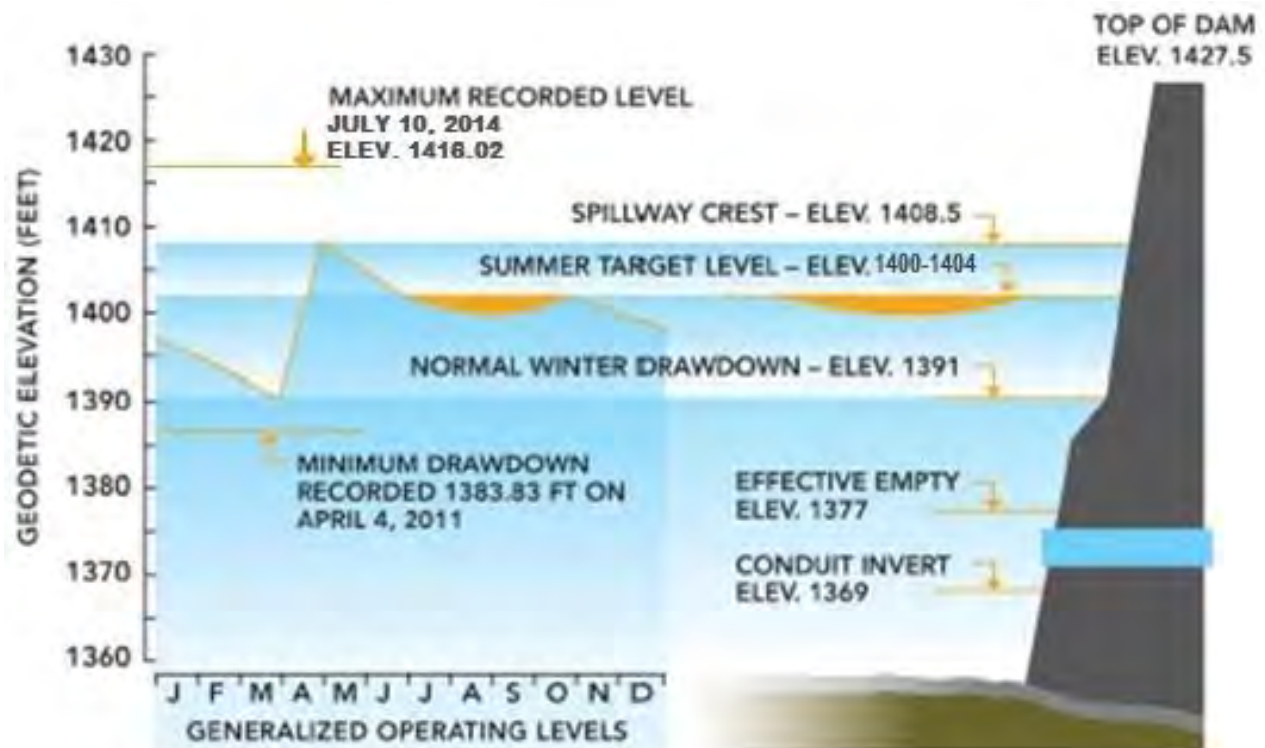
Figure 2: Shellmouth Reservoir operating levels

The reservoir is capable of storing approximately 387,000 acre feet (477,365 dam³) of water at the spillway crest elevation of 1,408.5 feet (429.31 m) (see Figure 2).

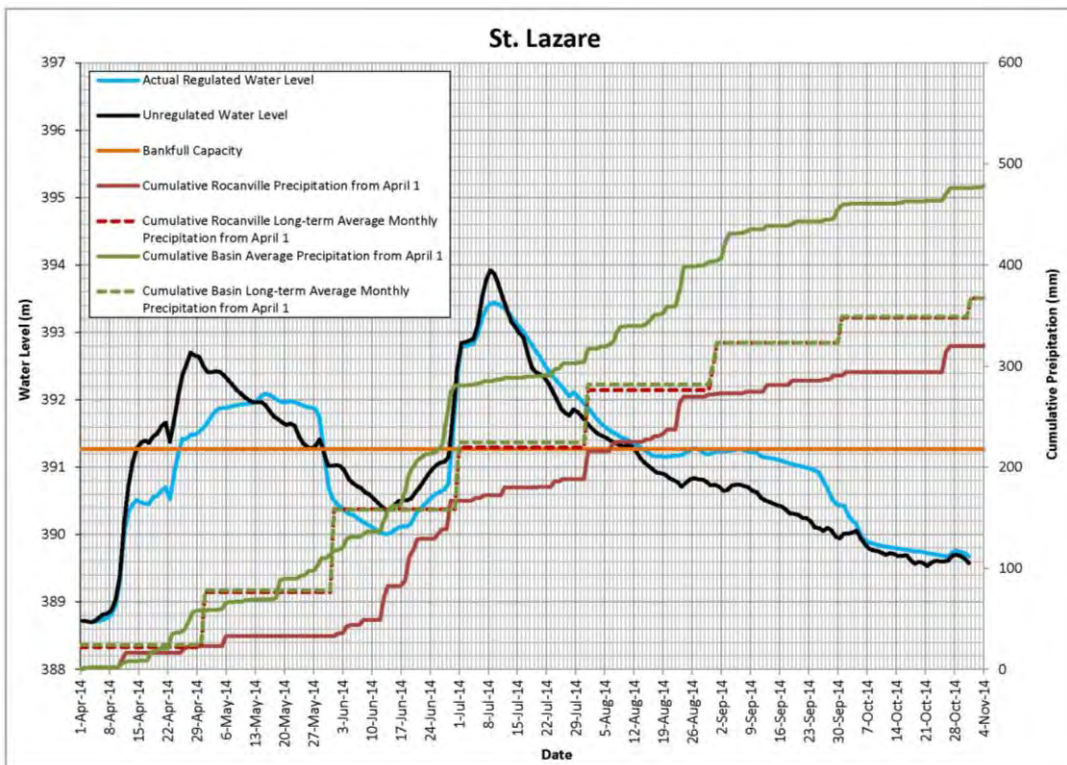
Figure 27: Hydrograph showing regulated and unregulated water levels at St. Lazare (m)
