Farm Structures

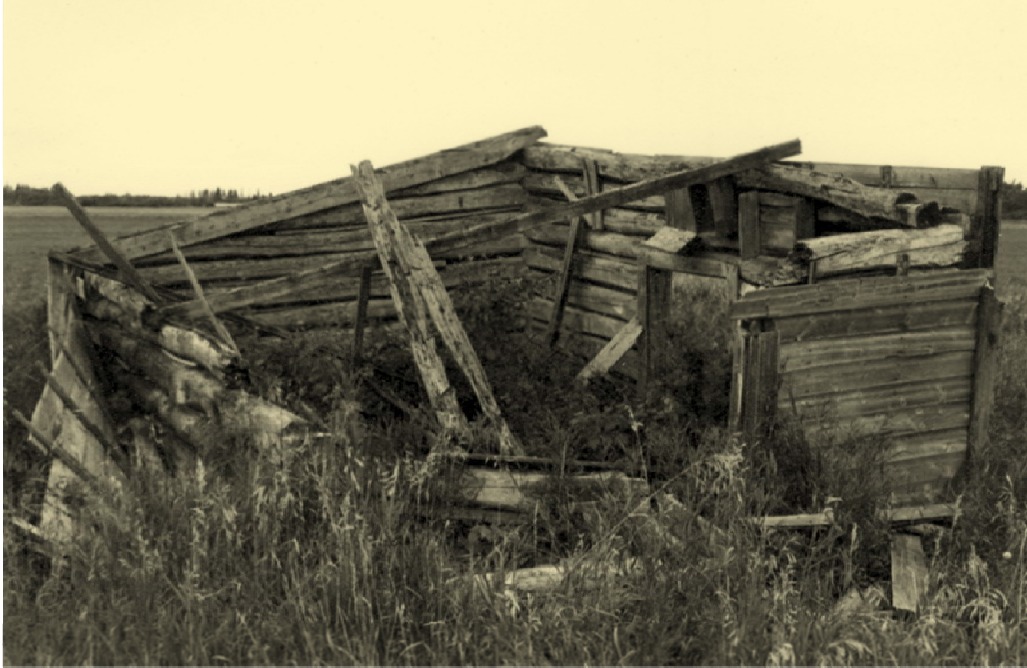
Figure 45

Sniefeld shed, SE 8-22-4E, circa 1895. Small shanty-roofed storage sheds such as this one were among the first farm buildings the Icelandic settlers constructed after staking claim to their homesteads.

Very few pre-1900 farm buildings remain. Only a single building of log construction was found - a shed on the same site as the Sniefeld log house (Figure 45). Small shed-roofed storage structures of this type were often found on the early homesteads.

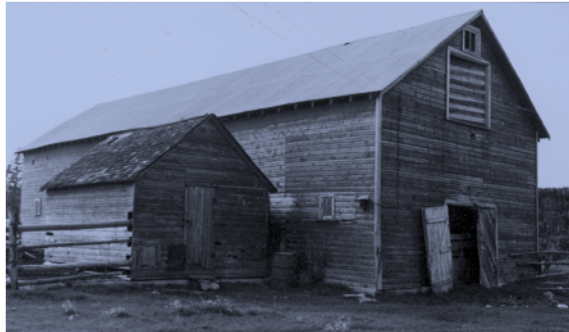
Figure 48

Many of the barns constructed during the 1920s were simply longer versions of the earlier gable-roofed barns, such as this Riverton area example.

Prior to the turn of the century, when livestock numbers were still quite small, simple log stables were used to shelter the animals (Figure 46). The oldest farm building of frame construction is a barn located just south of Riverton on River Lot 8 (Figure 47). The design is not unlike other barns of the period found in most other parts of the province. The simple gable roof was also found on many of the larger barns constructed during this period, of which there are several examples remaining (Figure 48).
