Later Structures (1885-1900)

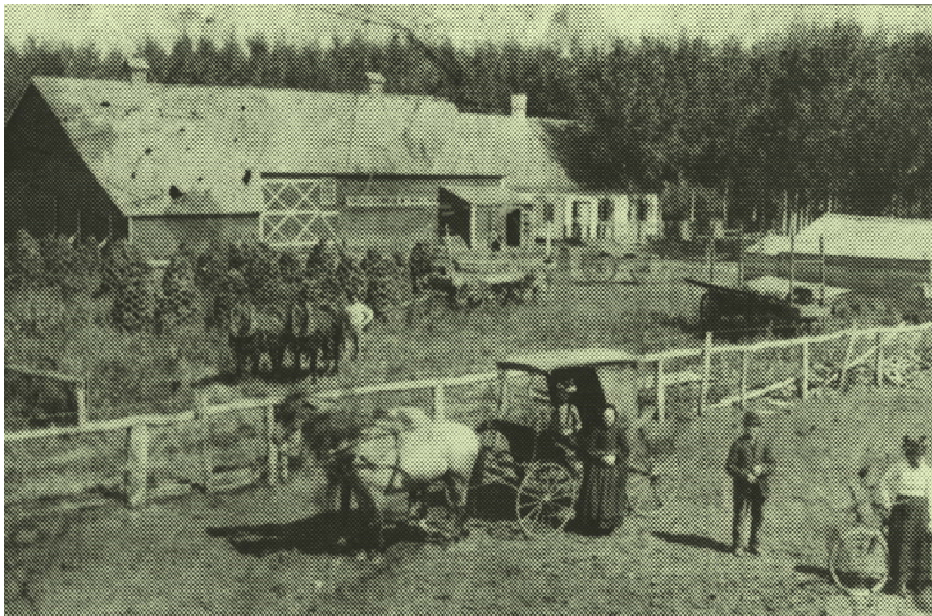
Figure 19

Isaac Wiens farmstead, Rosebach, 1895. (Winkler, 1982: 25).

Depending upon the care with which they were constructed, and the economic progress of the settler, most of the early house/barn units were replaced within ten years of their construction. The earlier structures were usually dismantled to make room for the new house at the front of the yard lot because this, by tradition, was where a Mennonite house was located. As the necessary time and resources were generally now available, the new house/barn units were large and carefully constructed with close attention given to many of the traditional elements such as floor plan and interior fixtures (Figure 19). Like the earlier units, the house and barn section were often constructed separately.

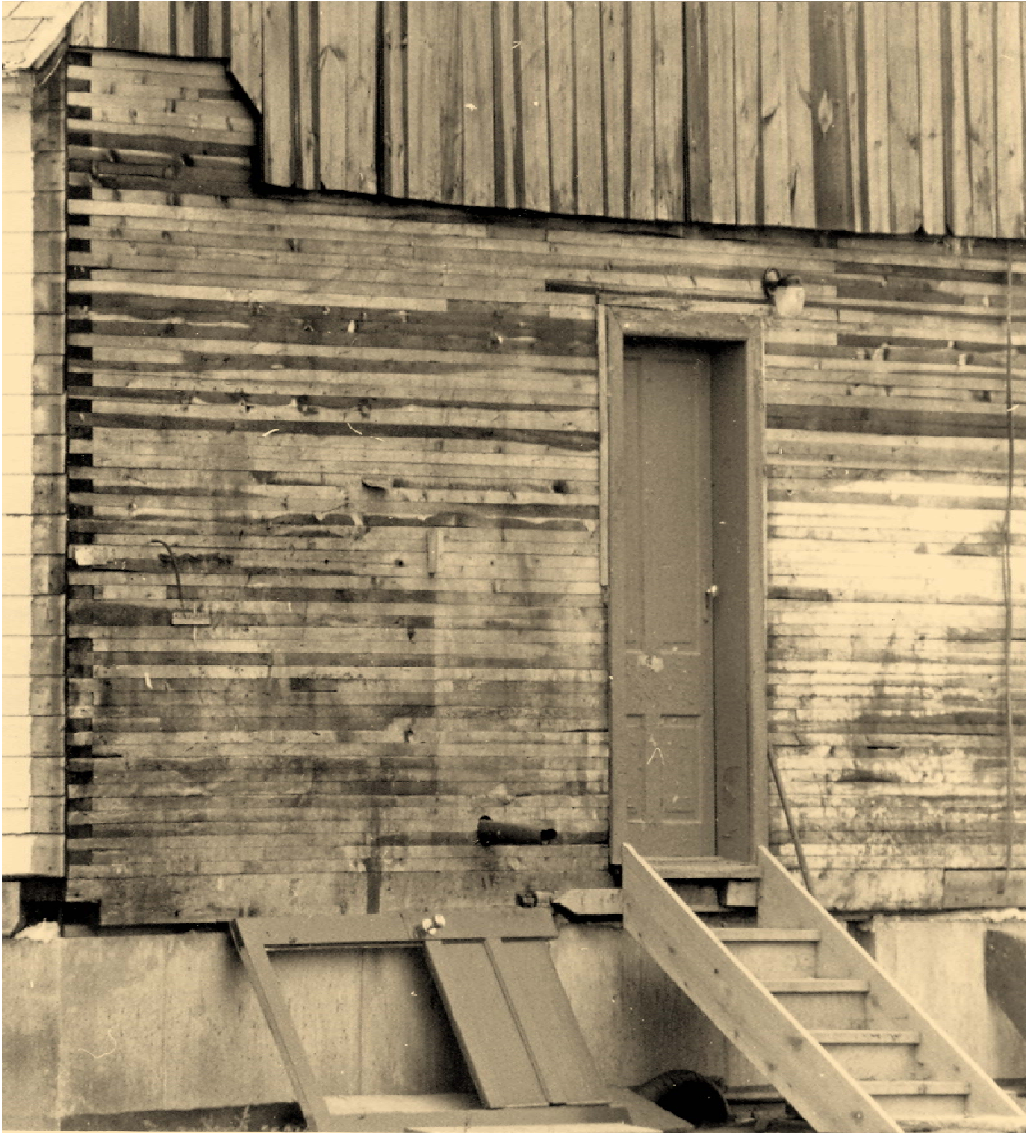
Figure 21

Corner detail: crib wall construction.

While houses built during the 1880s were generally still of log construction, those built during the 1890s featured a light timber frame or sometimes a stacked-lumber system more commonly used in the construction of cribbed grain elevators (Figure 20 and 21).

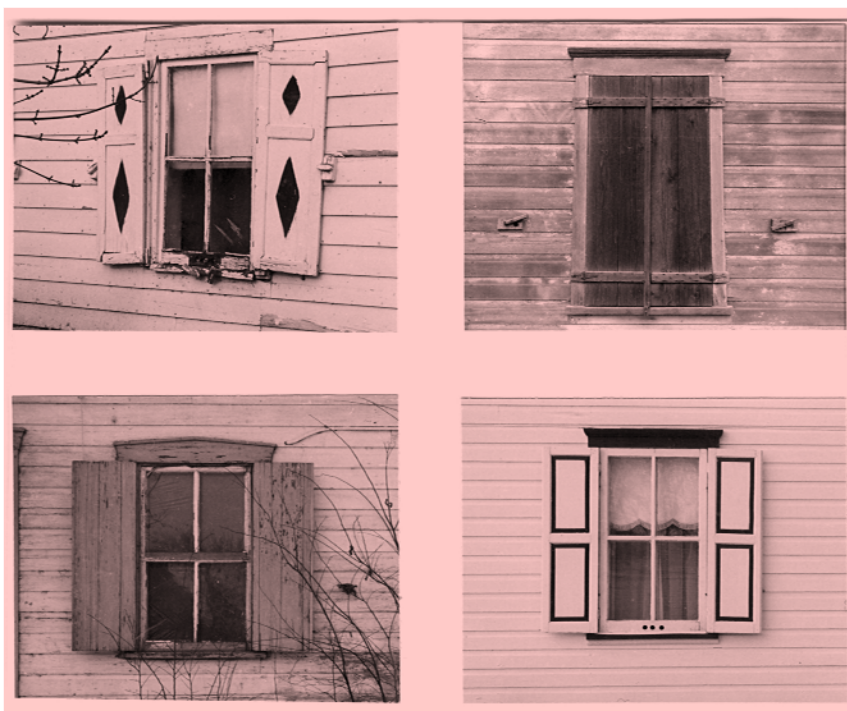
Figure 22
Mennonite houses constructed in the MSTW district, before the turn of the century, were characterized by exterior wooden shutters.

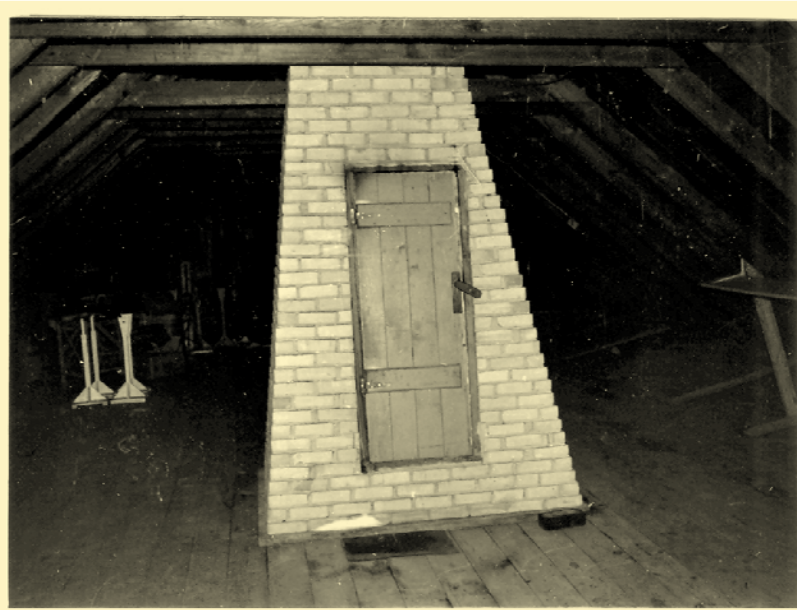
Figure 24

Many of the traditional Mennonite houses had smoke chambers built into the chimney above the kitchen area for curing meats.

Above the ceiling of the cooking room, in the attic, a large tapering chimney or "Rajka Koma" was often constructed. This chimney served a double purpose. It not only kept sparks from flying out too quickly and igniting the roof, (this was especially important when thatched roofs were common), but it also could be used as a smokehouse for curing meats. The chimney was usually about two metres square at the bottom. Access to it, for cleaning or inserting meat, was gained through a large metal door. None of the remaining house/barn units in the MSTW district still have either the central cooking room or the smoke chamber above it; the only known house with these features was previously located in the village of Chortitz, and it is now situated in the Mennonite Village Museum in Steinbach (Figure 24). The interior walls of the new homes were initially lined with shiplap, but in later years this was often covered with wainscott panelling and wall paper (Figure 25). The ceiling joists, which were invariably exposed, were usually cut square and the bottom corners bevelled (Figure 26).

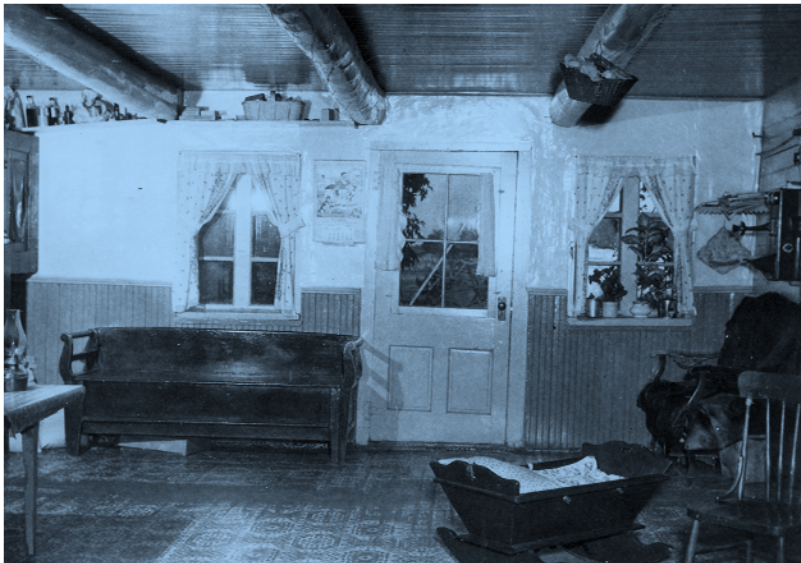
Figure 25

Interior of one of the better preserved early Mennonite homes as photographed during the 1950s. (Provincial Archives Manitoba)

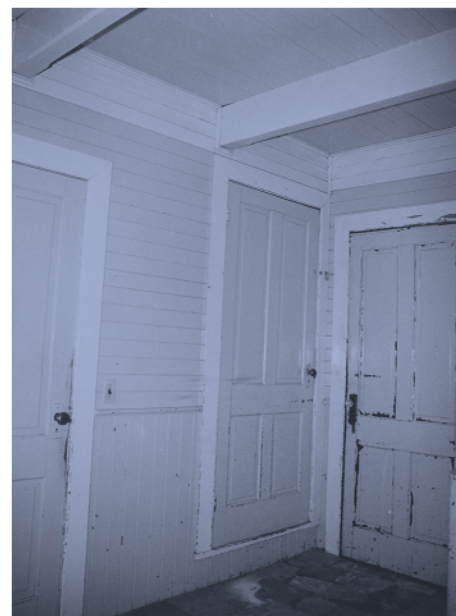
Figure 26

Former Heide residence, Village of Hochfeld: interior view showing exposed joists, wainscoting and doorways leading to (left to right) the pantry, the attic and the barn.

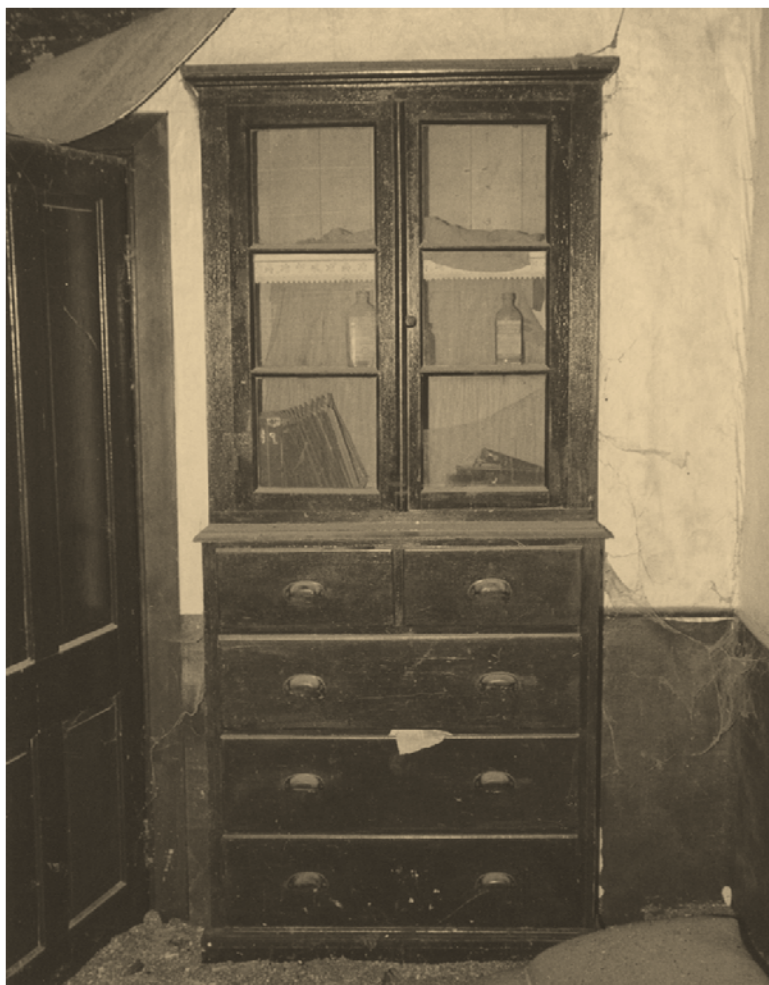
Figure 27

The "Glauss Shaup" was a standard interior fixture in most Mennonite homes.

This simple bevel was actually one of the few decorative features in the largely utilitarian design of the house. Another standard interior fixture was the "Glauss Shaup" or china cabinet built into the walls of the "Groote Shtov" next to the brick heater (Figure 27).

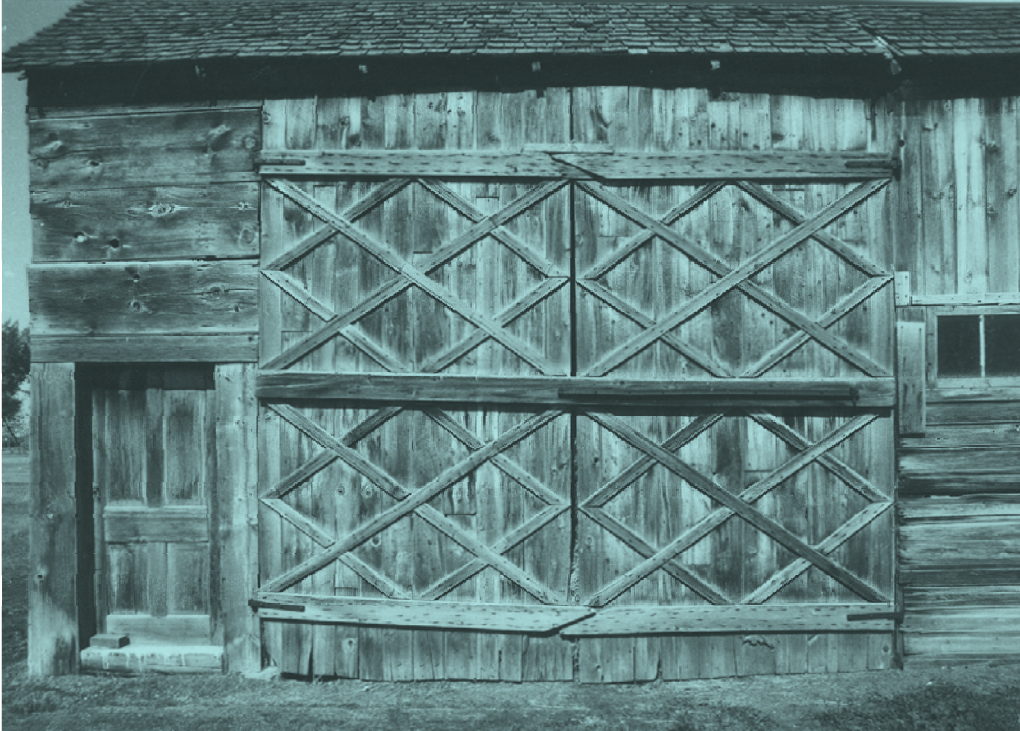
Figure 34

Typical "Sheen" doors. The criss-crossing pattern was typical of Mennonite barns in both Prussia and Russia and was found on virtually all traditional style barns in Manitoba.

The "Sheen" was traditionally the area where the threshing of grain was conducted. It consisted of two sections: a large open area where the threshing floor was located, and an adjacent storage area; the lower level of which was used to store the various types of grain and a loft area above where the straw was stored for use as livestock bedding. This section of the barn was characterized by two large doors which allowed a team and wagon to be driven directly into the area (Figure 34).

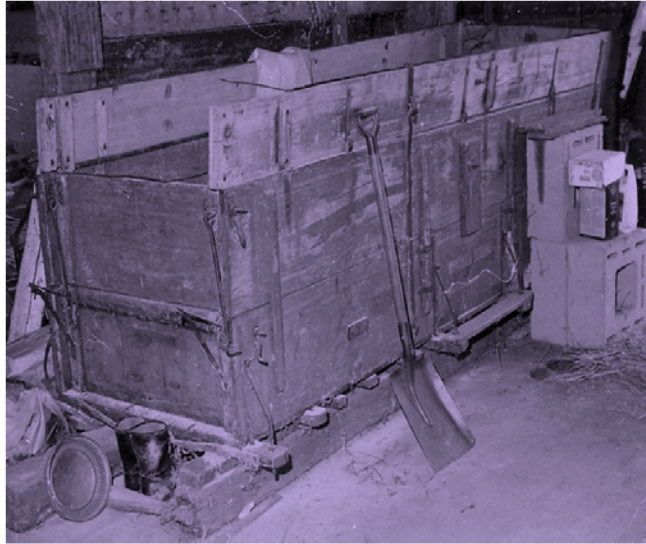
Figure 35

The "Sheen" area in many Mennonite barns was used to store items such as wagons and cutters.

Although present in many of the barns constructed in the MSTW district, the "Sheen" section soon took on a different function than originally intended. By the time the Mennonites who settled in Manitoba could afford to construct large traditional barns, steam-powered threshing machines were becoming available. As all threshing activities were now conducted outside, the "Sheen" was no longer required and was put to use as an extra storage area for hay and equipment. In the Ens barn, a cutter, wagon, and miscellaneous other items are still being stored in this area, as they were in years past (Figure 35).

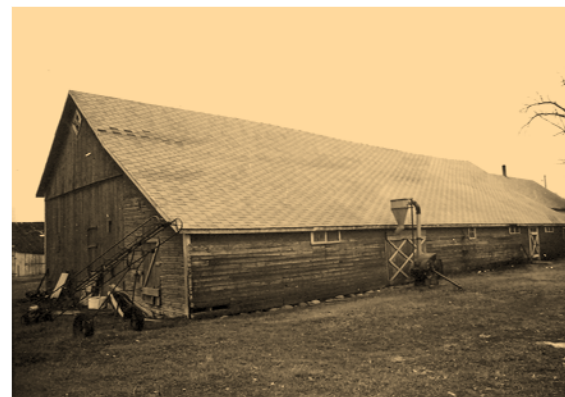
Figure 36
Hiede barn, Village of Hochfeld.
A number of barns in the MSTW
villages had wide "Owesied"
sections, part of which acted as a
second stable area.

The "Owesied" was a section created by the continuation of the roof, almost to the ground. As a result, it was often only two or three meters wide. One long continuous "Owesied" section along the rear side of the barn was most common, although occasionally this was divided into two separate sections by a second set of large doors giving access to the "Sheen" and which allowed a wagon to be driven directly through the barn. Also, a number of barns had an additional short "Owesied" on the front of the barn. The primary purpose of the "Owesied" was the storage of livestock feed, seed grain and fuel, as well as housing poultry and hogs. In some cases, however, the slope of the roof on the rear 'Owesied" was reduced, allowing for a much wider space, and in these cases, the portion located adjacent to the stable area was used for extra horse and cattle stalls (Figure 36).

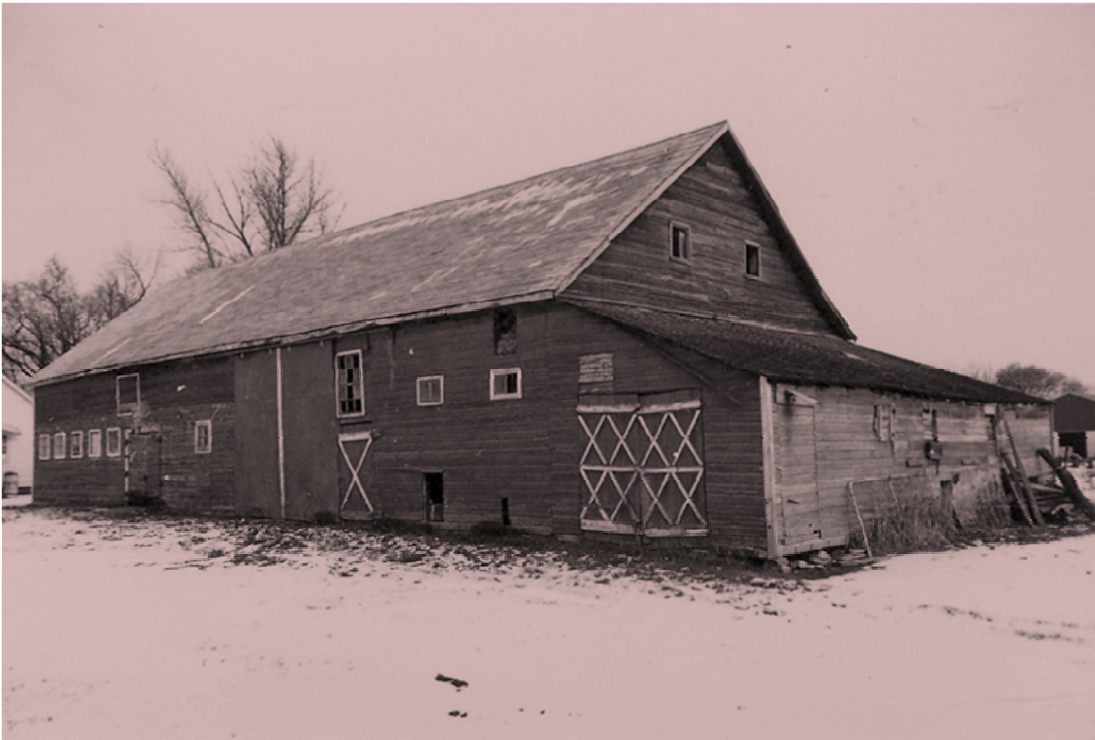
Figure 37
P.A. Rempel barn, Village of Neuenburg. Although not part of the traditional barn design, a rear "Sheua" section was often added to the barns in the MSTW district.

Another common feature of many of the Mennonite barns was the "Sheua". This was a large shed roofed section attached to the far end of the barn and used for machinery storage or as a fowling and calving area (Figure 37).

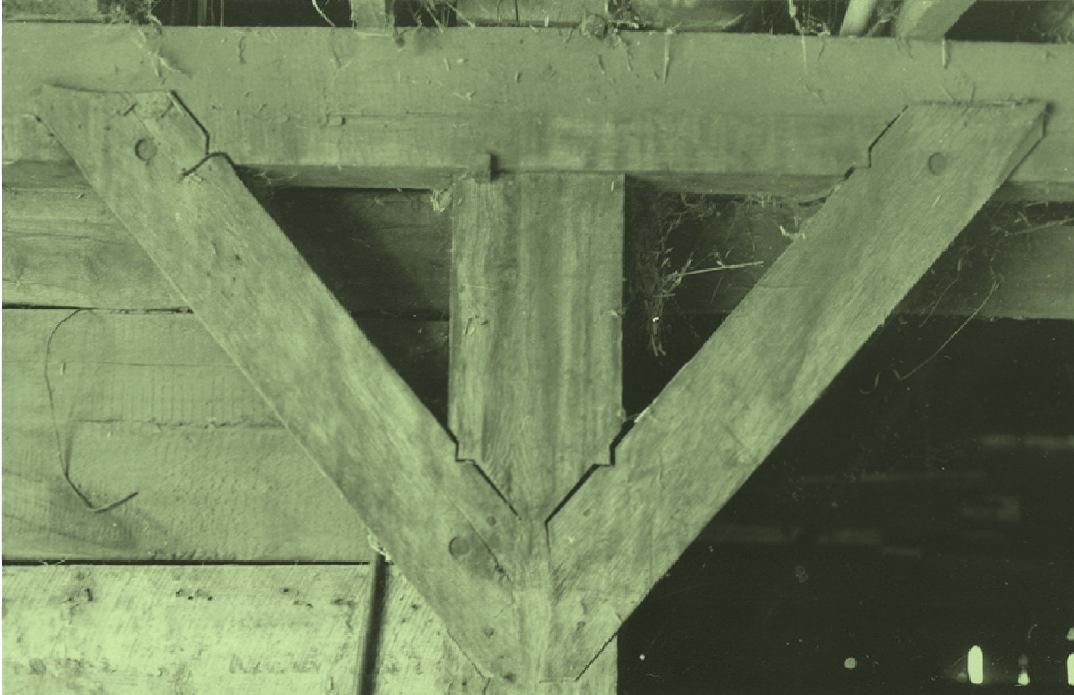
Figure 43

The sway braces in most Mennonite barns featured an unusual lap notch.

Standard mortise and tenon notches were used at all the perpendicular joints while an unusual type of formed lap-notch was used in all the diagonal joints (Figure 43).

This type of notch, in Manitoba, appears to be exclusive to structures of Mennonite origin, and was no doubt transplanted from Europe as was the entire barn design. All the major joints were secured with wooden pegs. Like the more conventional mortise and tenon joints, the Mennonite lap joints were usually expertly cut and fitted. Examples were found where even a paper-clip could not be forced into the joint seam.
