November 18, 2016

RE: Your File: 3960.00, Fairway Colony Wastewater Treatment Lagoon, Secondary Cell Liner

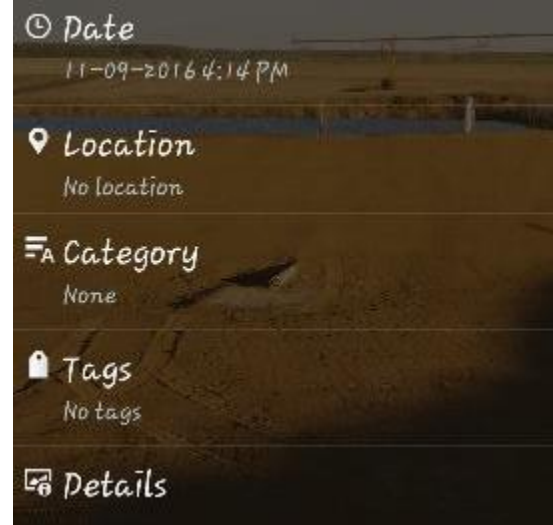
November 9, 2016 at 4:14pm.  
Ambient daytime temperature 20C, dry and sunny.  
Photo is taken from west berm looking east.  
Installation of ballast material is completed.  
Interconnecting pipe is visible.

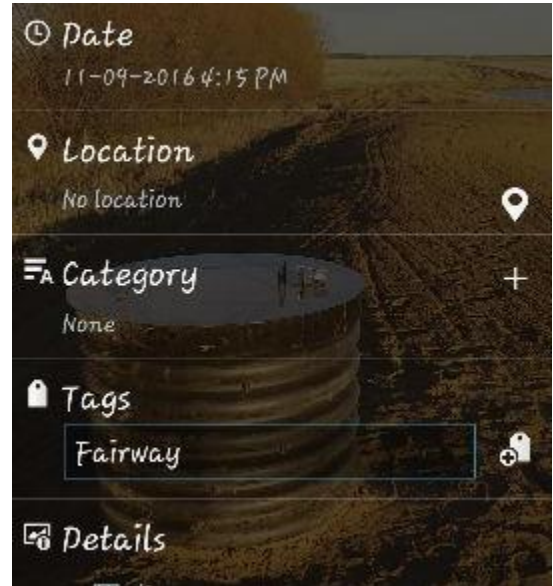
November 9, 2016 at 4:15pm.  
Ambient daytime temperature 20C, dry and sunny.  
Photo taken on north berm looking east.  
Sump is trimmed to 1.0m above top of berm.  
The cover is bolted in place, and was padlocked when EFM left site.  
The Owner Fairway Colony is responsible for installation of the dewatering pump.
