# RC2- PHASE 2

Project Number:  
21-001

Crocus Environmental Inc.

Project:  
Negative Air Covered Hazardous Pond

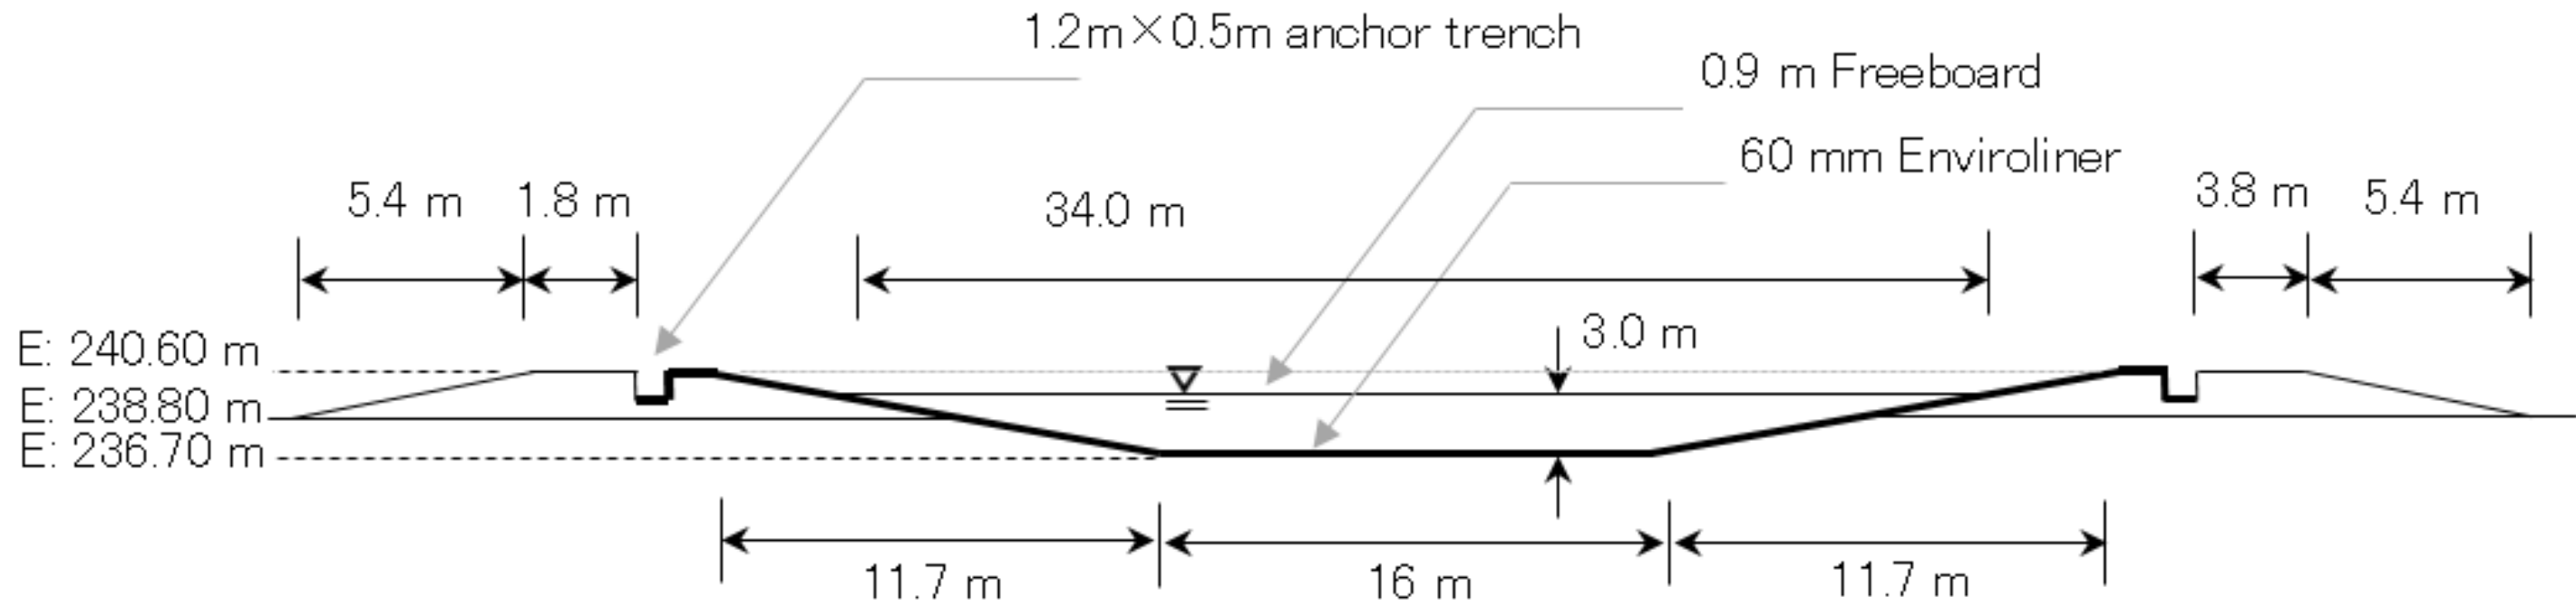
A - A

1. Slopes are 3:1
2. Elevations are based on the information that we received for the original location. New survey data is required for new accurate elevation.

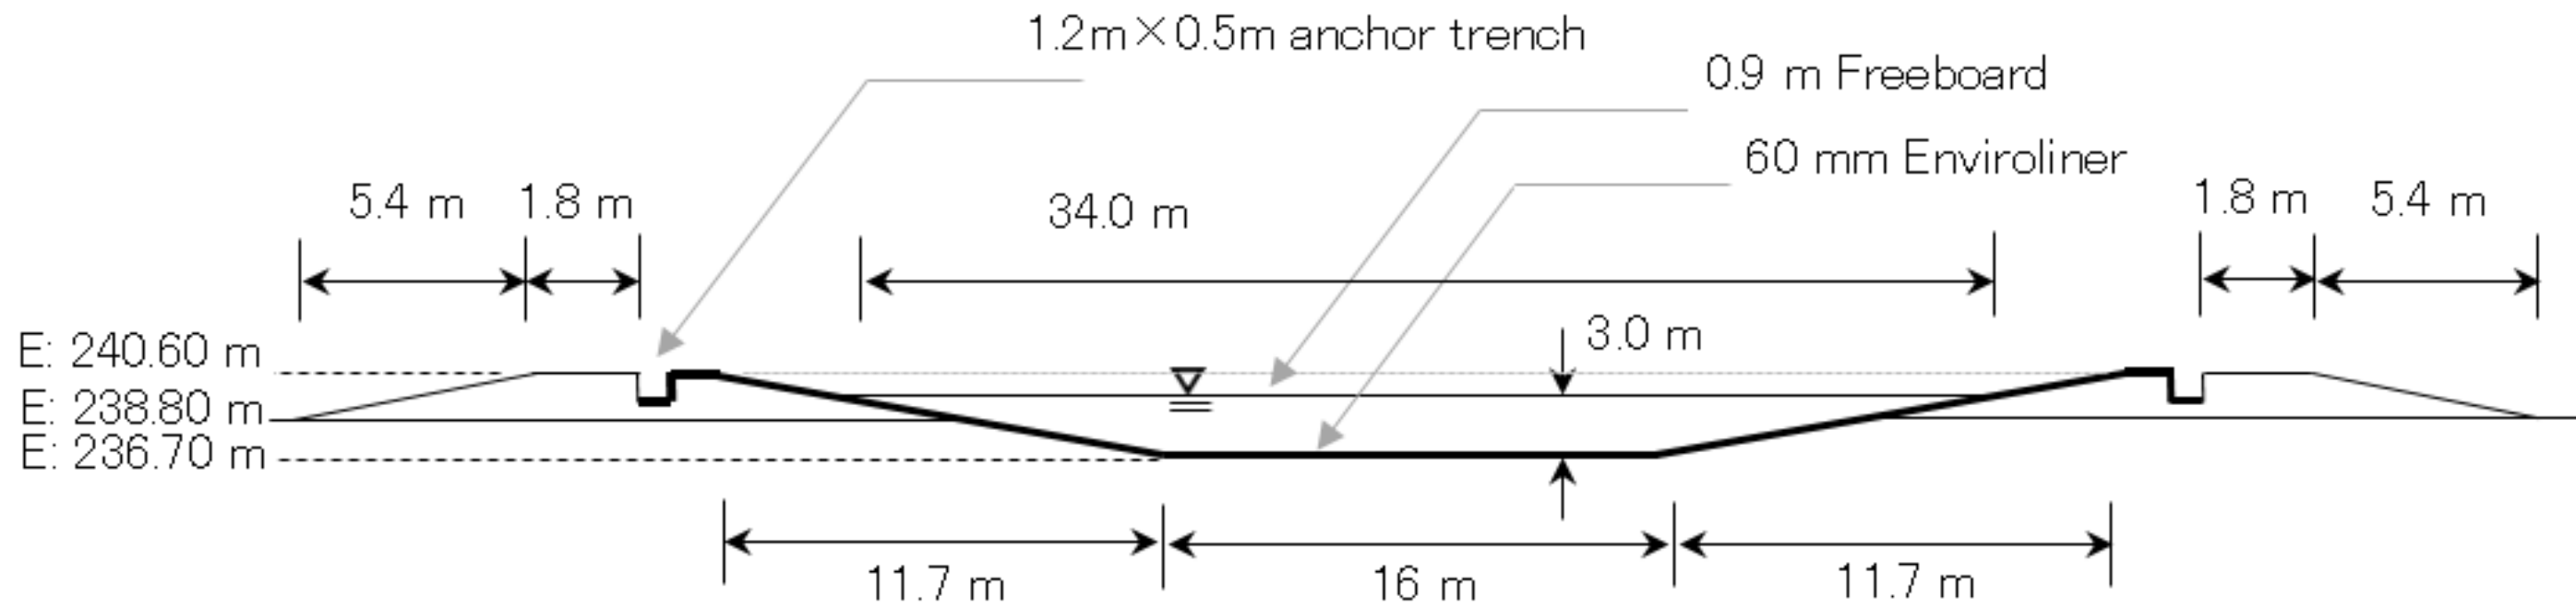
**B – B**

- 1. Slopes are 3:1

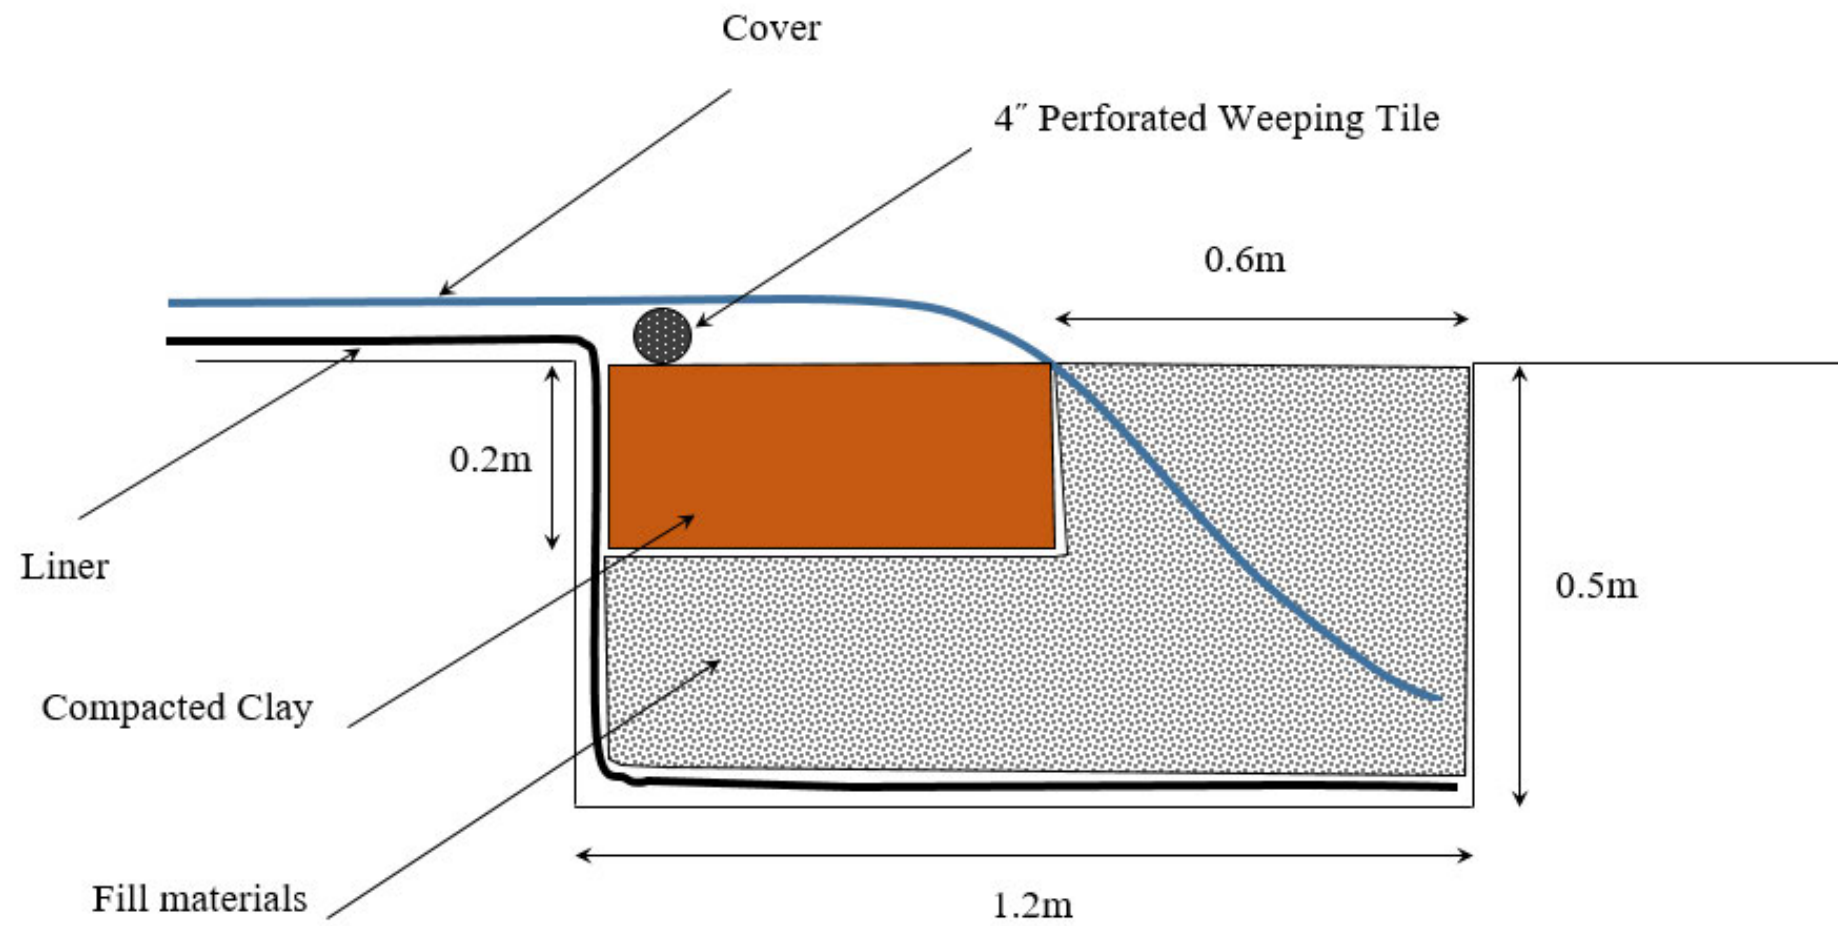
# C - C (I)

## Details of the anchor trench

1. On one side sand bags can be used instead of fill material to allow easy opening of the pond cover.

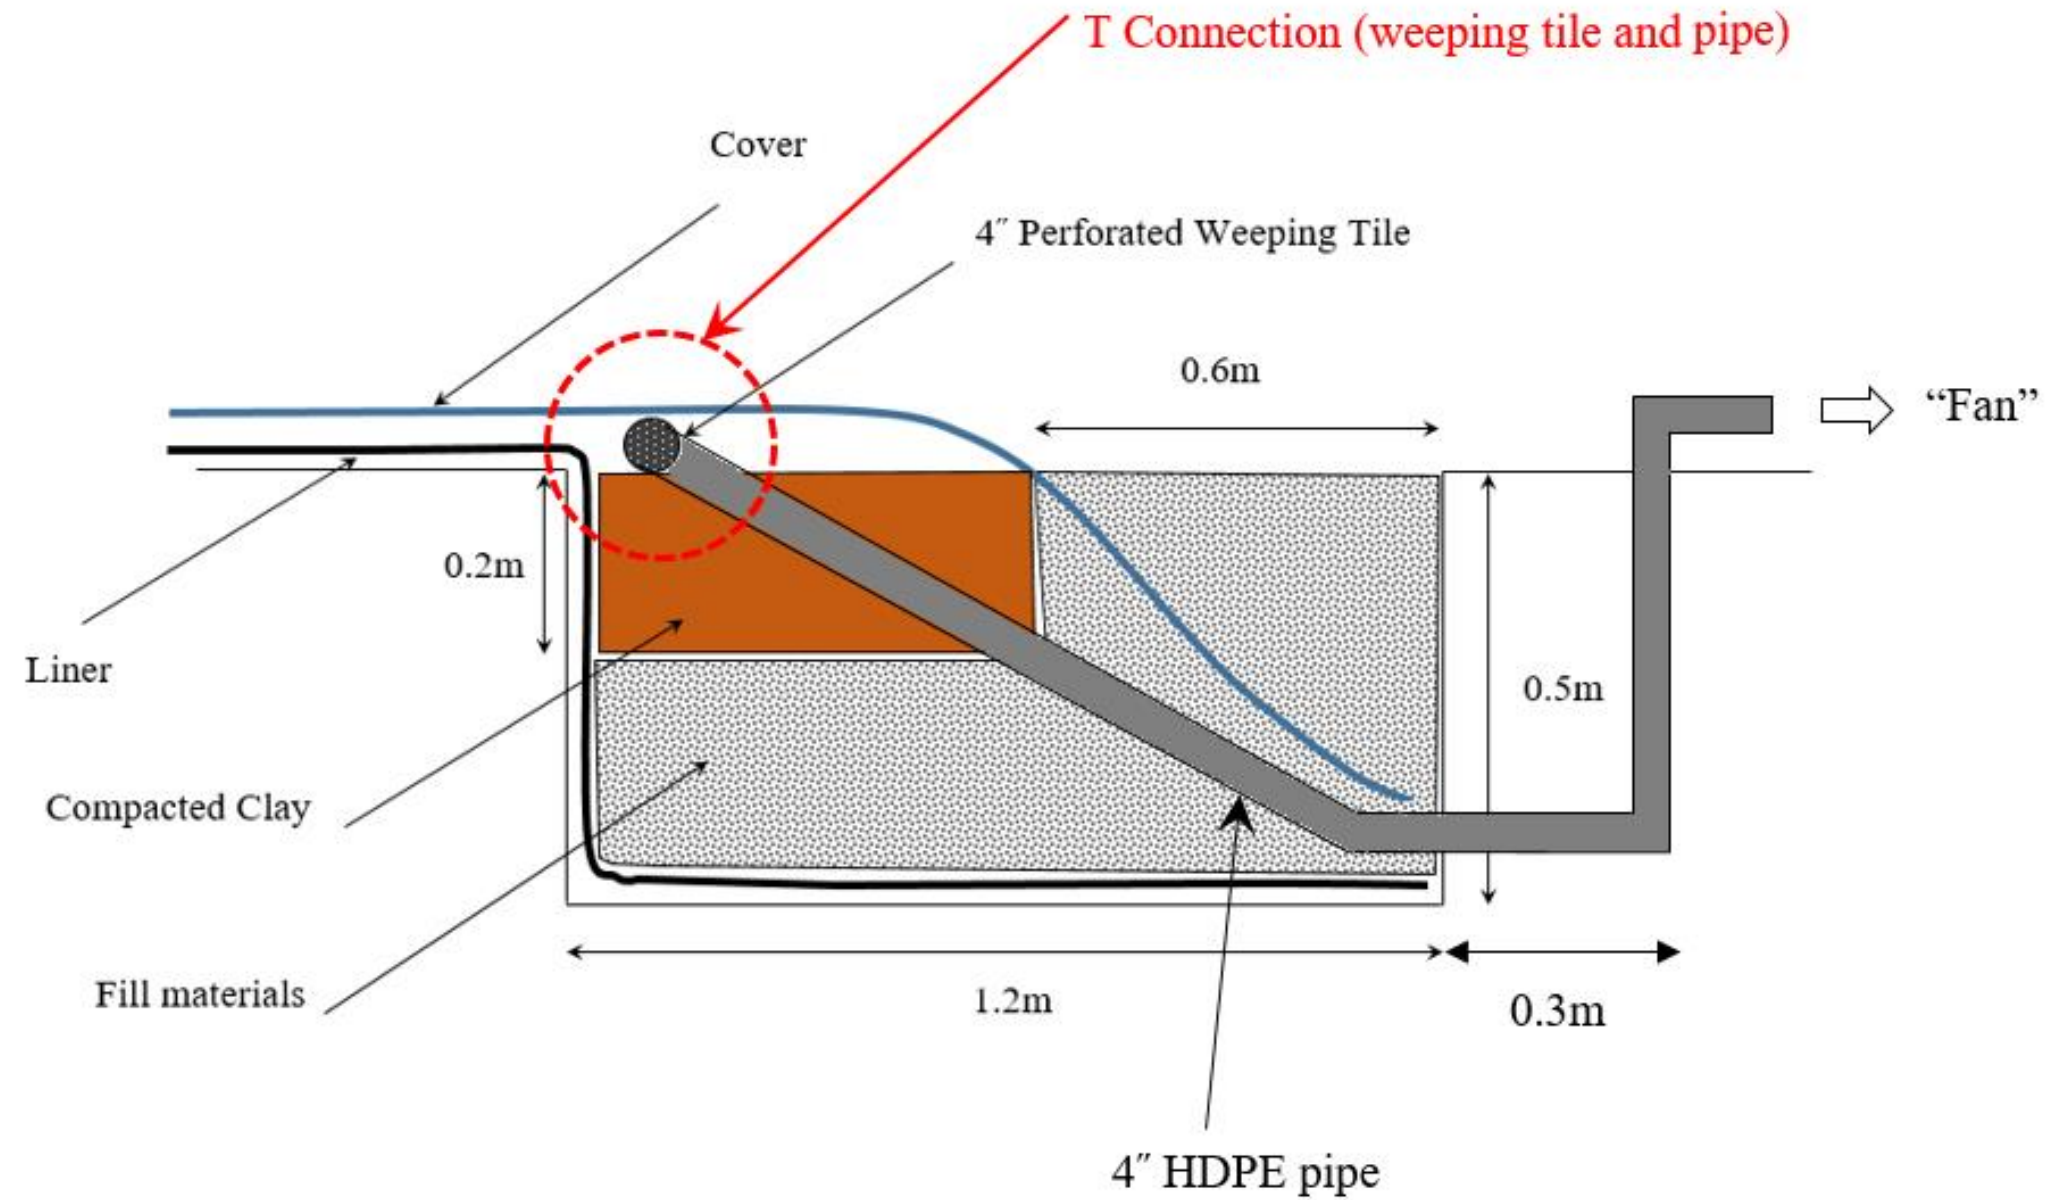
C - C (II)

Details of the weeping tile and connection to the fans

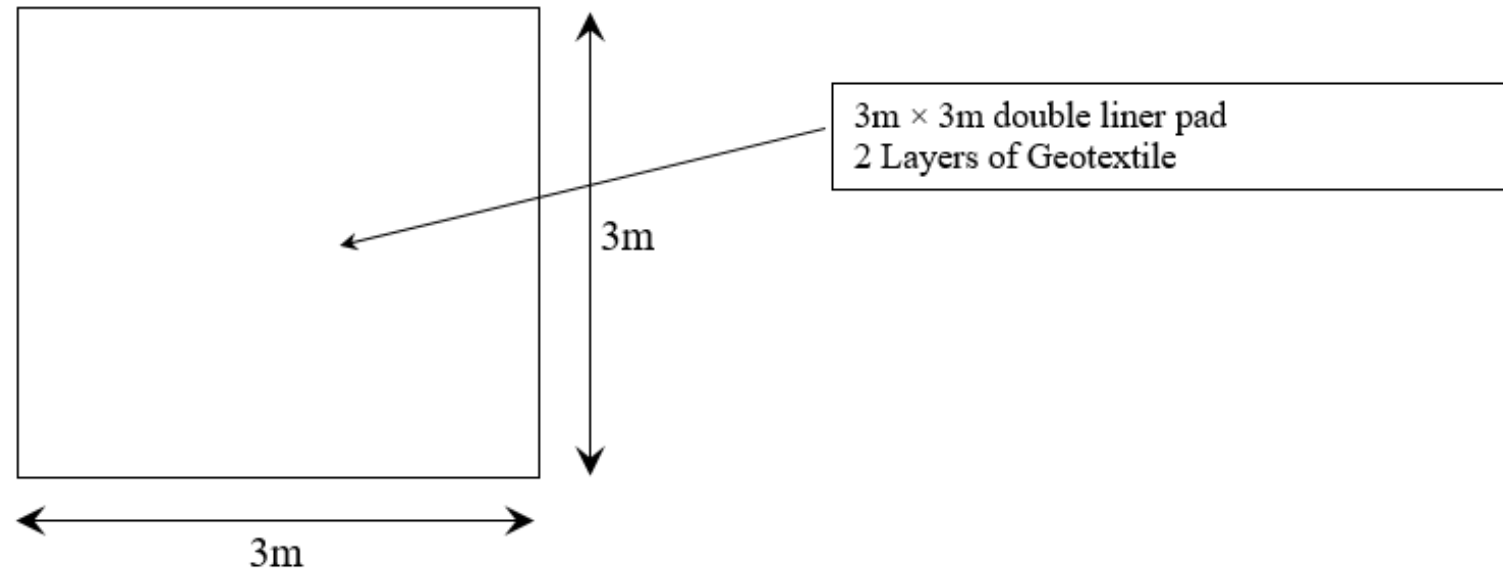
1 – Pad for discharge pipe

Client: Miller Environmental Corporation  Project: Negative Air Covered Hazardous Pond	Project Portion: Double Liner Pad for the Discharge Pipe  Scale: NTS	Page: 7/8
---	--	--	---	--	--	--------------

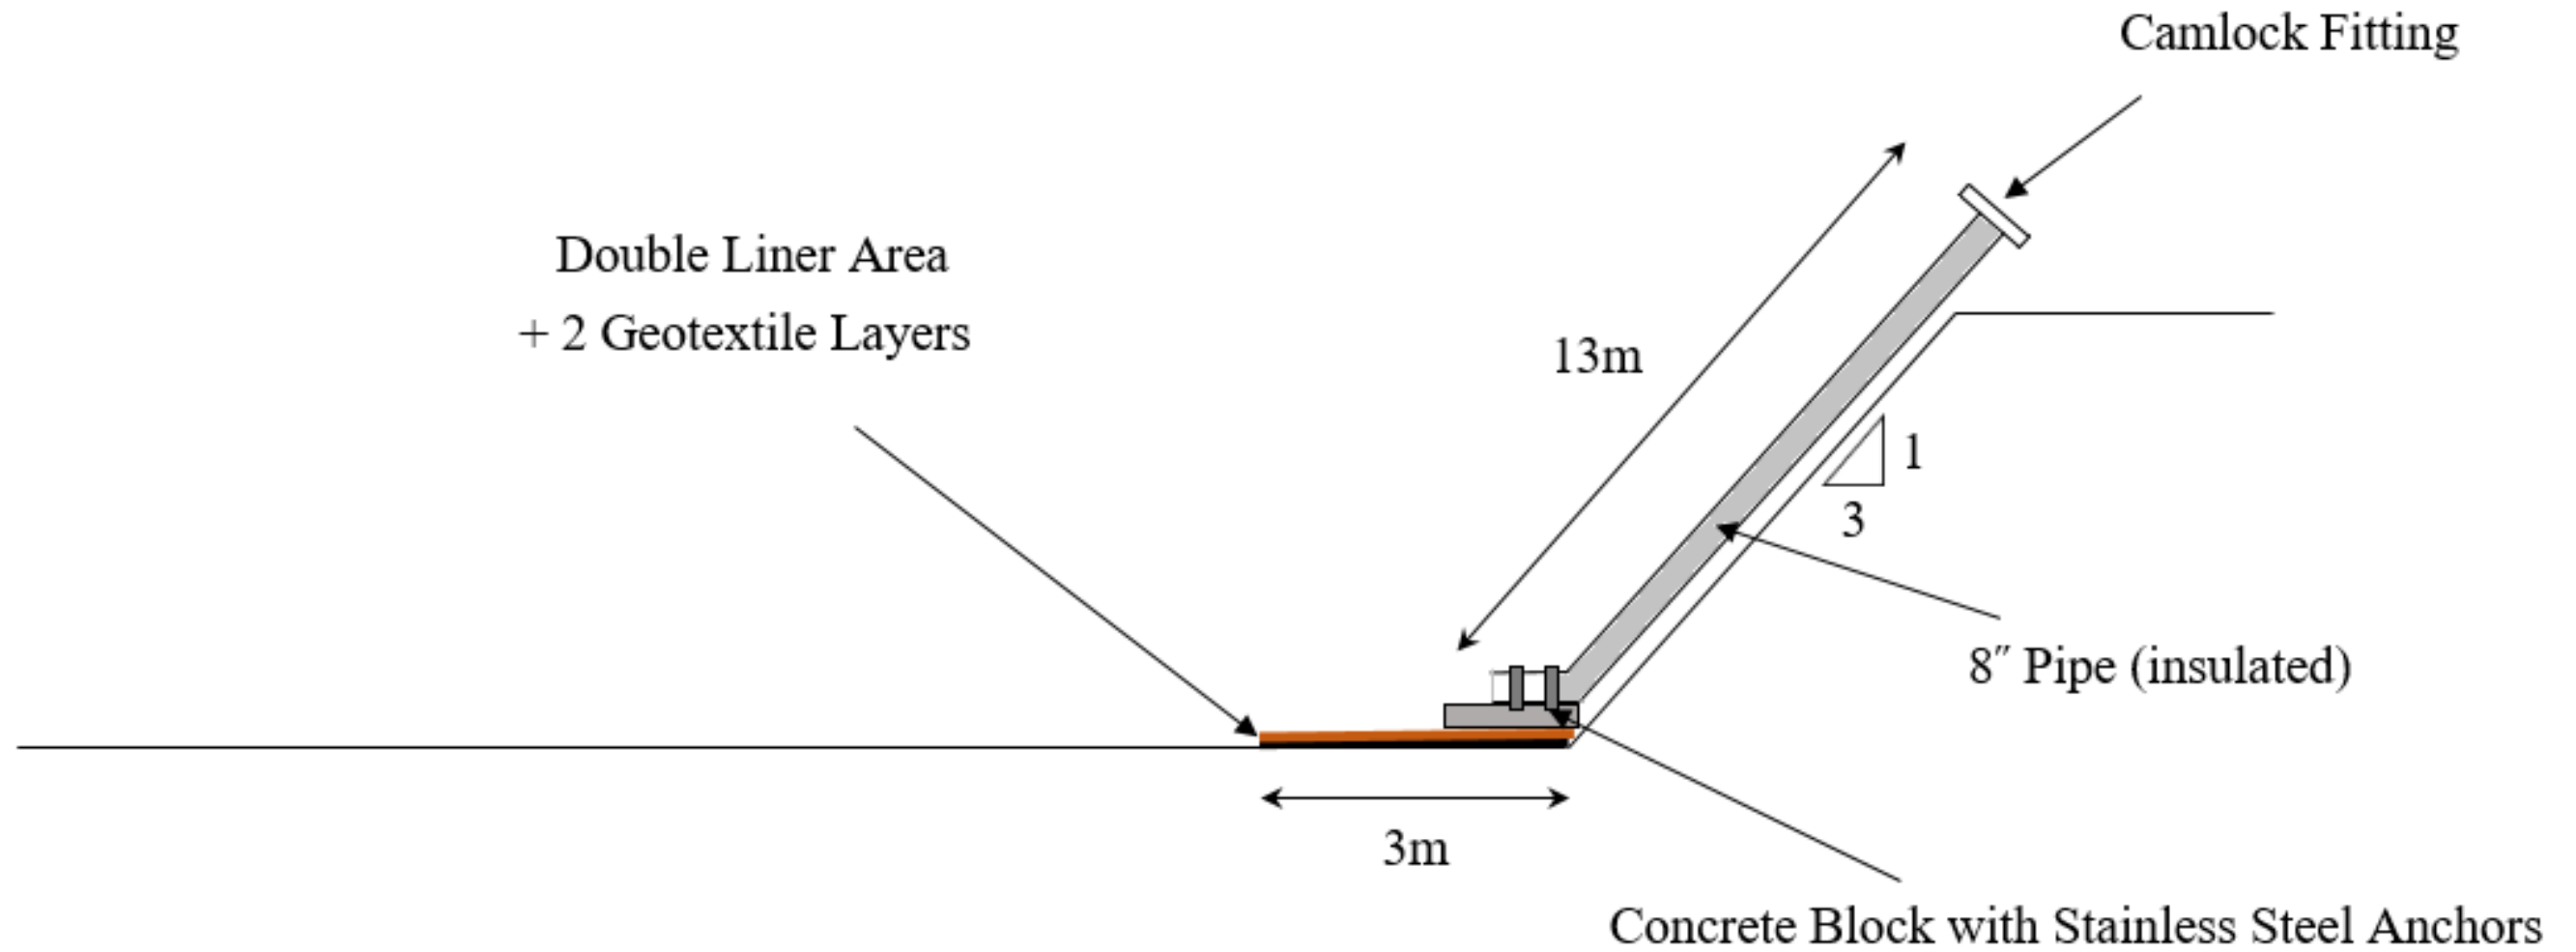
## 2 – Discharge and intake pipe

1. The concrete anchor and blocks can be also done on the slope.
